ELEVATOR CONDITION ASSESSMENT

123 King Street West, Hamilton, ON

August 2022

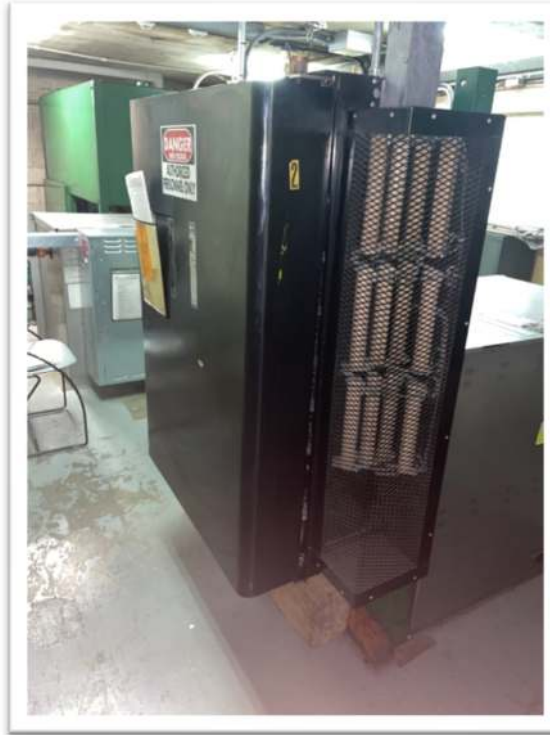
Elevator 2 controller is original with the pumping unit having been replaced in 2015 by Otis. The controller has reached the end of its engineered life and can be considered obsolete.

IMAGE 3 – Elevator 2 controller - original

Complete modernization – Now at an age of 46 years, the elevator system of cars 2 and 3 have surpassed its engineered life expectancy. Modernization is required in the short term: the existing controller and pumping units require replacement. A modernization typically also involves the replacement of door operating equipment, operating buttons and fixtures, as well as replacement of all wiring.

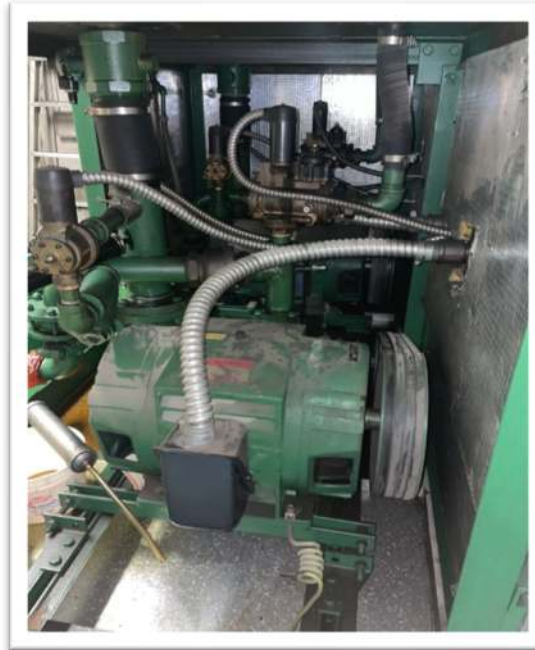
The major components on Freight Elevator 3 appear to be original controller is original with the pumping unit having been replaced in 2015 by Otis. The controller and pumping units have reached the end of their engineered life and can be considered obsolete.

IMAGE 5 – Freight Elevator pumping unit - original
