## **Addendum # 2**

### **Bid Opportunity: 25-7636-RFT - Forest Heights Collegiate Institute Tech Room Revitalization and Partial Window Replacement Closing Date: Monday, February 24, 2025 2:00 PM**

## **PROJECT-SPECIFIC DESIGNATED SUBSTANCE & HAZARDOUS MATERIALS ASSESSMENT**

**RE: Project-Specific Designated Substance & Hazardous Materials Assessment  
Forest Heights Collegiate Institute  
255 Fischer-Hallman Road, Kitchener, Ontario**

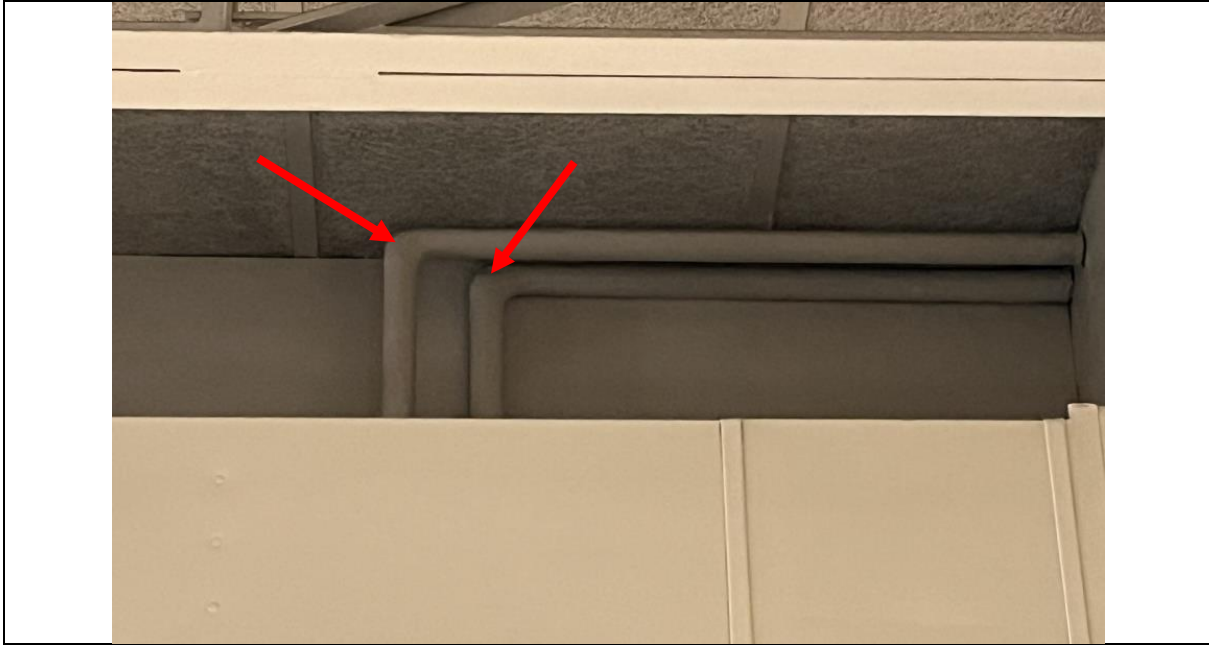
**P1 – Asbestos-Containing Mechanical Pipe Fittings**

Asbestos-containing mechanical pipe fittings identified in Classroom 8-3 (red arrows).

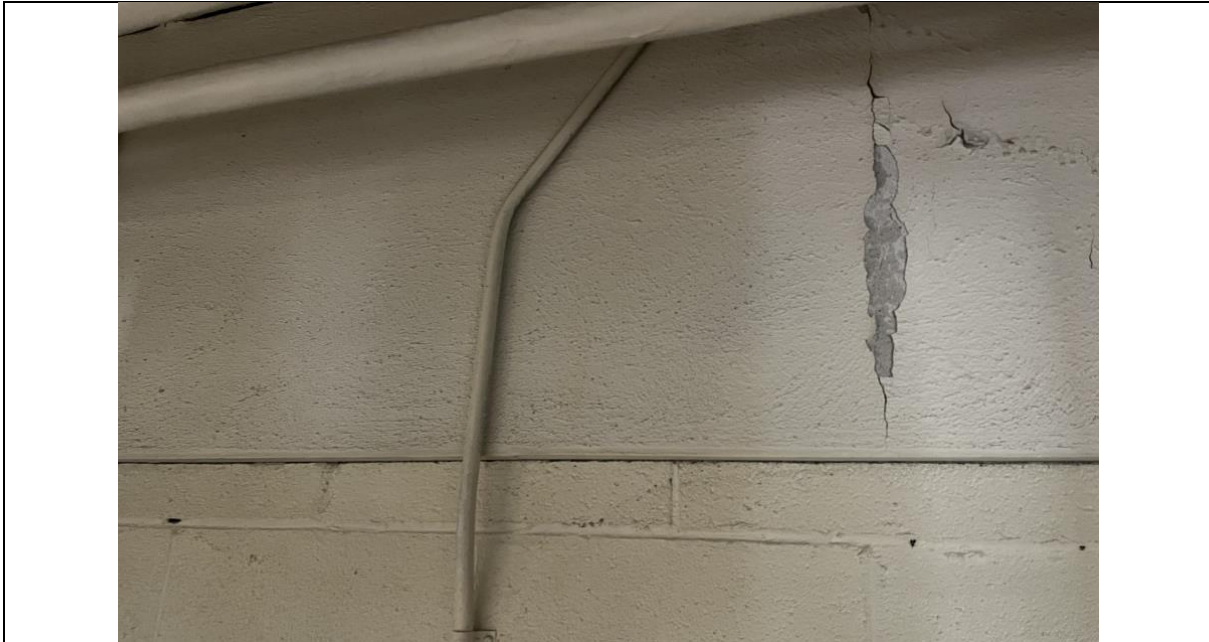
**P2 – Asbestos-Containing Textured Plaster Panels**

Asbestos-containing textured plaster panels were identified along the wall in classroom 8-5.

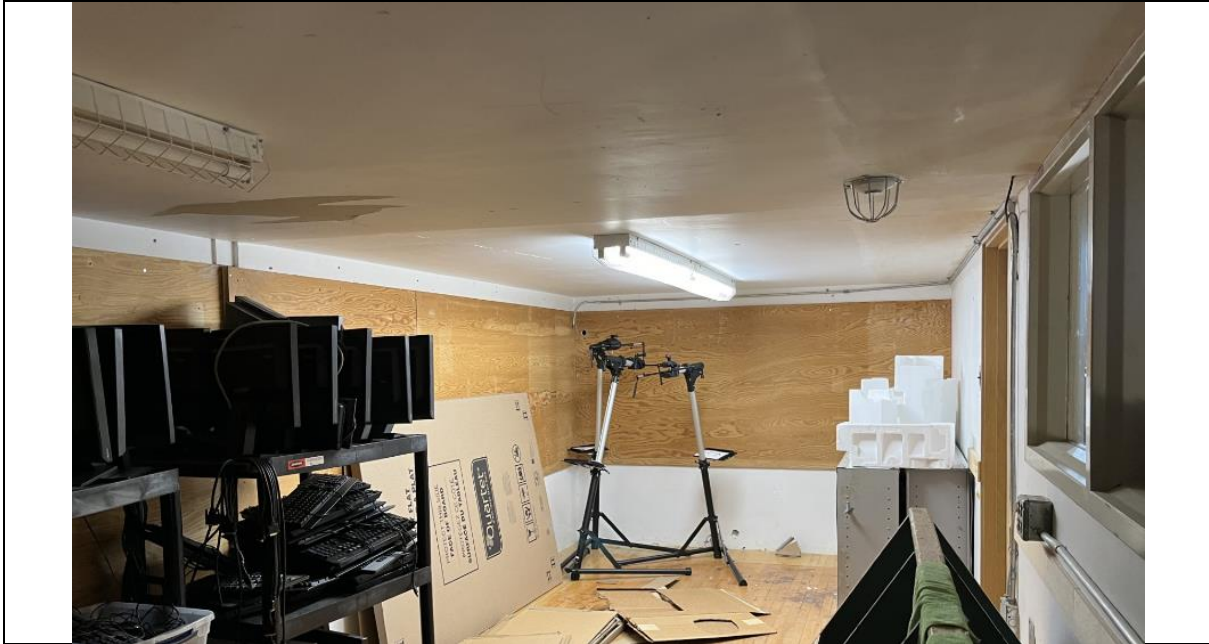
**P3 – Asbestos-Containing Drywall Ceiling Finish**

Asbestos-containing drywall ceiling finishes were identified in classroom 8-7A.

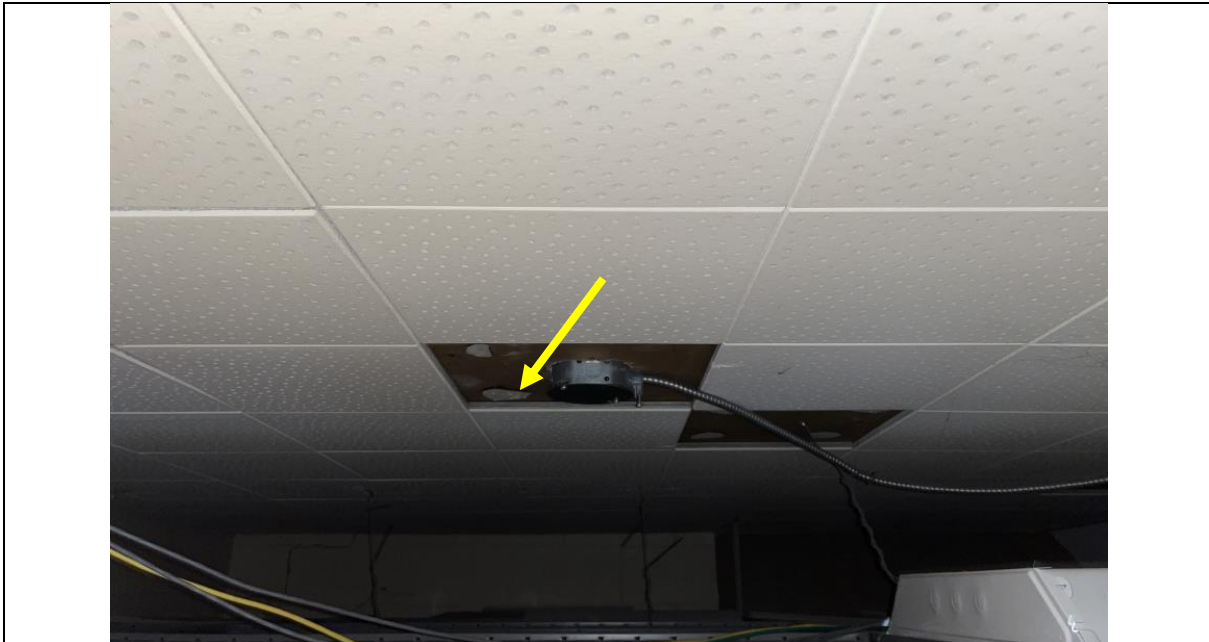
| Architectural Finishes & Finishing Materials | Location/Description | Cond. | Est. Quantity | Friability |
|---|---|---|---|---|
| Fixed-in-Place Ceiling Tiles | 1'x1' fixed-in-place pinhole patterned ceiling tiles were observed above the ceiling in in staff room 2-2B (P4). This material was sampled during a previous environmental survey and was determined to be asbestos-containing (refer to the report referenced in Section 1.3). | Good | ~50m <sup>2</sup> | Non-Friable |

**P4 – Asbestos-Containing 1'x1' Fixed-in-Place Ceiling Tiles and Associated Mastic**

Asbestos-containing 1'x1' fixed-in-place ceiling tiles with a pinhole pattern and the associated asbestos containing mastic (yellow arrow) were identified above the lay-in ceiling in staff room 2-2B.

Non-friable asbestos-containing materials in GOOD condition can be managed in place until all activities which could result in disturbance of this material. Prior to scheduled renovation work, non- friable asbestos-containing materials must be removed. Removal

of non-friable asbestos-containing materials shall be performed following Type 1 operations, provided that the material is wetted down and removed using non-powered hand-held tools, as outlined in Ontario Regulation 278/05, Designated Substance – Asbestos on Construction Projects and in Buildings and Repair Operations, made under the Ontario Occupational Health and Safety Act. If the material cannot be adequately wetted, Type 2 operations apply.

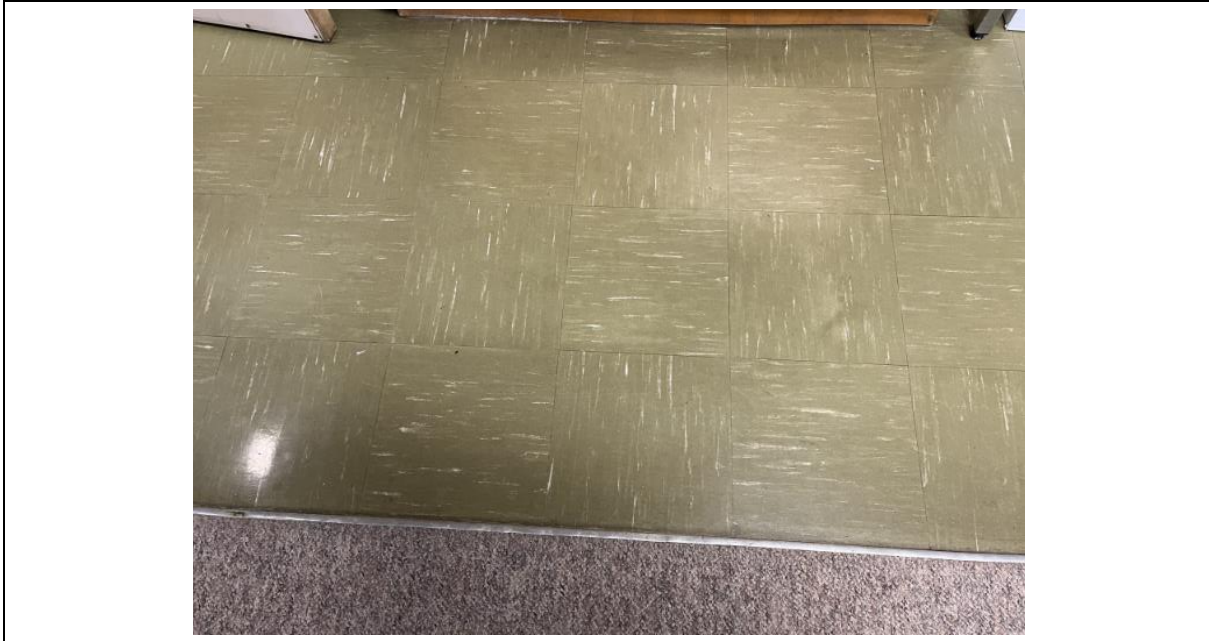
**P5 – Asbestos-Containing 12"x12" Green Vinyl Floor Tiles**

Asbestos-containing 12"x12" green vinyl floor tiles were identified within staff room 2-2B.

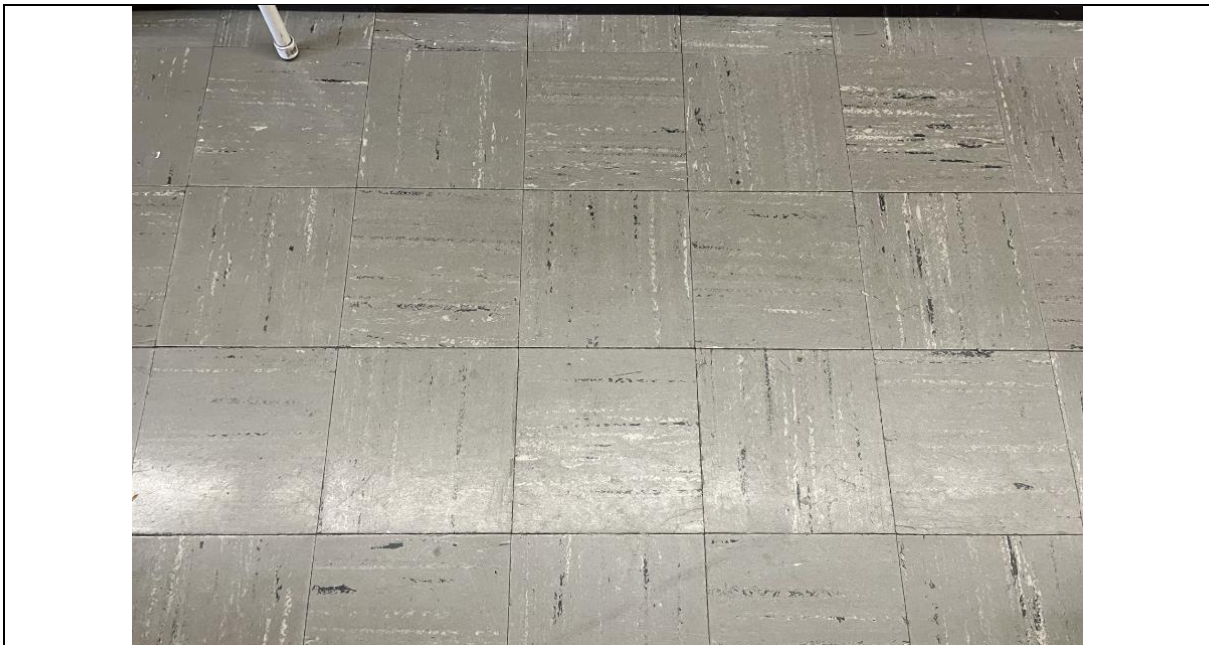
**P6 – Asbestos-Containing 9"x9" Grey with White Streak Vinyl Floor Tiles**
