Designated Substance Survey Report

41 Jackson St., W.

Hamilton, Ontario

Project: C6084

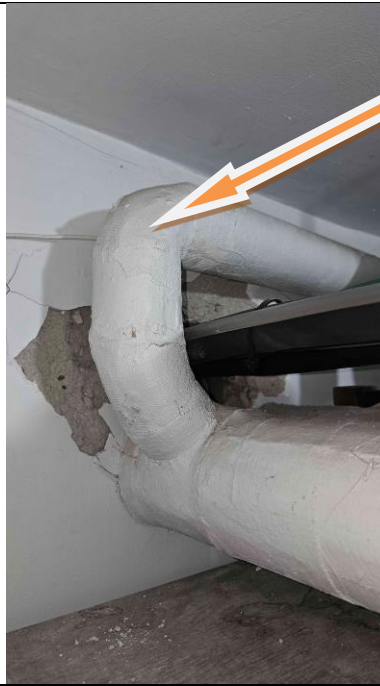
Three (3) samples of parging cement insulation present on pipe fittings throughout the Basement Level of the building were collected and analyzed for asbestos content (samples 0004 A-C). The parging cement insulation has been analytically determined to contain **chrysotile asbestos**. Parging cement insulation is a friable material. The chart below details locations, conditions and approximate quantities:

Location	Approximate Quantity of Fittings		
	Good	Fair	Poor
Kitchenette (Location 5)	8 EA		
Office (Location 6)	6 EA

Photo 1 – **Asbestos-containing** paring cement on pipe fittings.

1. Less than 1 square meter of asbestos-containing parging cement shall be abated utilizing Type 2 asbestos abatement precautions, as outlined in Ontario Regulation 278/05.
2. Greater than 1 square meter of asbestos-containing parging cement shall be abated utilizing Type 3 asbestos abatement precautions, as outlined in Ontario Regulation 278/05.

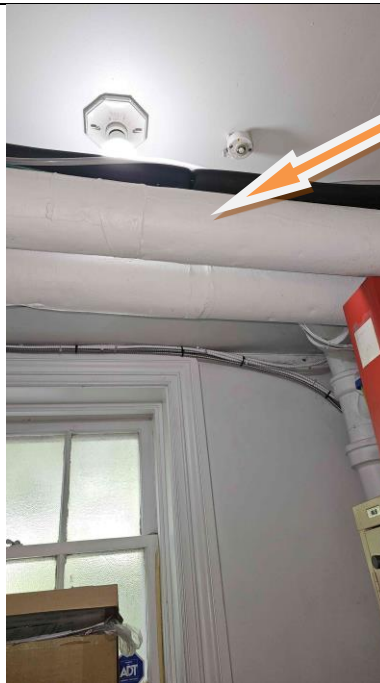
Three (3) samples of aircell insulation present on pipe straights throughout the Basement Level of the building were collected and analyzed for asbestos content (samples 0005 A-C). The aircell insulation has been analytically determined to contain **chrysotile asbestos**. Aircell insulation is a friable material. The chart below details locations, conditions and approximate quantities:

Location	Approximate Linear Footage		
	Good	Fair	Poor
Kitchenette (Location 5)	15 LF		
Office (Location 6)	20 LF

Photo 2 – **Asbestos-containing** aircell insulation on pipe straights.

1. Less than 1 square meter of asbestos-containing aircell insulation shall be abated utilizing Type 2 asbestos abatement precautions, as outlined in Ontario Regulation 278/05.

2. Greater than 1 square meter of asbestos-containing aircell insulation shall be abated utilizing Type 3 asbestos abatement precautions, as outlined in Ontario Regulation 278/05.

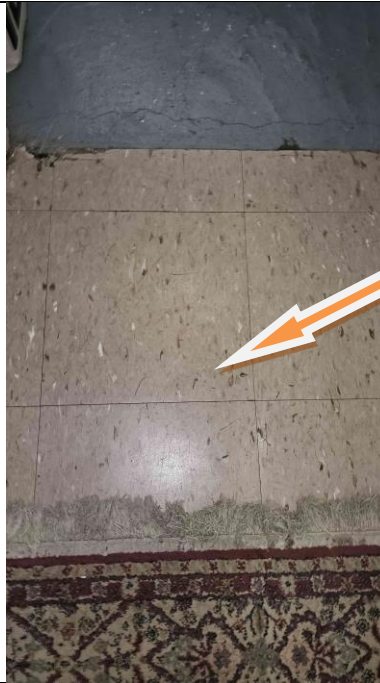
Three (3) samples of 12" x 12" beige with brown and white flecks vinyl floor tile and mastic adhesive (VFT-01) present in the Basement Hallway (Location 4) were collected and analyzed for asbestos content (samples 0002 A-C). Both the vinyl floor tile and mastic adhesive have been analytically determined to be non-asbestos.

Photo 3 – Non-asbestos 12" x 12" beige with brown and white flecks vinyl floor tile and mastic adhesive (VFT-01).

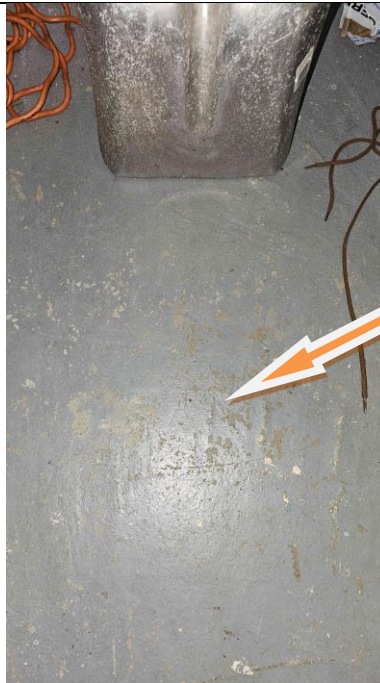
The grey paint present on the concrete floor in the Kitchenette is in poor condition (peeling and flaking).

Analytical findings identifying greater than 0.1% lead content in paint indicates the paint has the potential to create a hazard to humans or the environment in certain conditions. See Section 5.0 for further details.

Photo 4 – **Lead-containing** grey paint on basement floor.

For details on the requirements and procedures regarding lead removal, please refer to Ontario Regulation 490/09, Ontario Regulation 213/91 and the Ministry of Labour prepared – Lead on Construction Projects Guideline.
