NEW VISION UNITED CHURCH

Designated Substance and Hazardous Materials Assessment

24 Main Street West,
Hamilton, Ontario

May 29, 2019

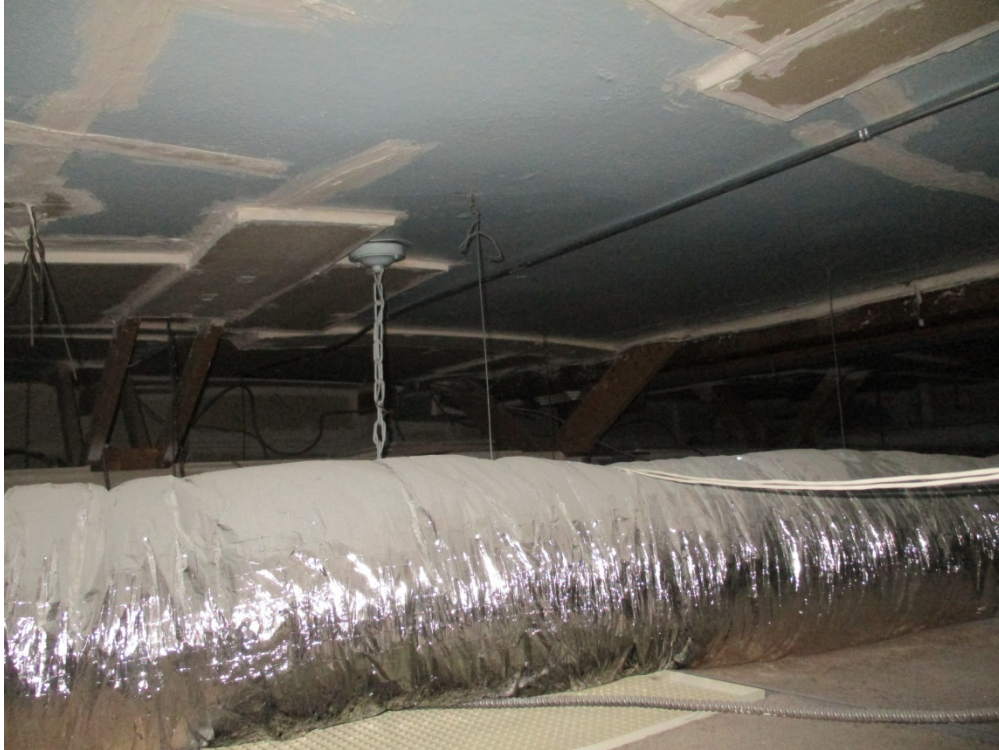
- Vinyl sheet flooring:
 - Vinyl sheet flooring in the foyer washroom (S06A) reported 10% Chrysotile and is considered ACM.
- Plaster and skim coat:
 - The skim coat layer of sample S02A collected from the basement area on April 2, 2019 reported 1% Chrysotile, while the plaster backing reported non-detect for asbestos.
 - Plaster samples taken from the Sanctuary area on May 1, 2019 reported non-detect for asbestos in both layers.

- Skim coat layers throughout the Site shall be deemed as ACM until additional sampling delineates the locations of ACM plaster materials at the Site.

Photograph No. 1 – The skim coat layer of plaster walls and ceilings throughout the Site is considered asbestos-containing.

ACMs were identified during the assessment. If these materials, including those deemed or suspected, will be disturbed, or will likely be disturbed, during building maintenance, renovations, construction, or demolition activities, they must be handled and disposed of in accordance with the procedures prescribed by O. Reg. 278/05.

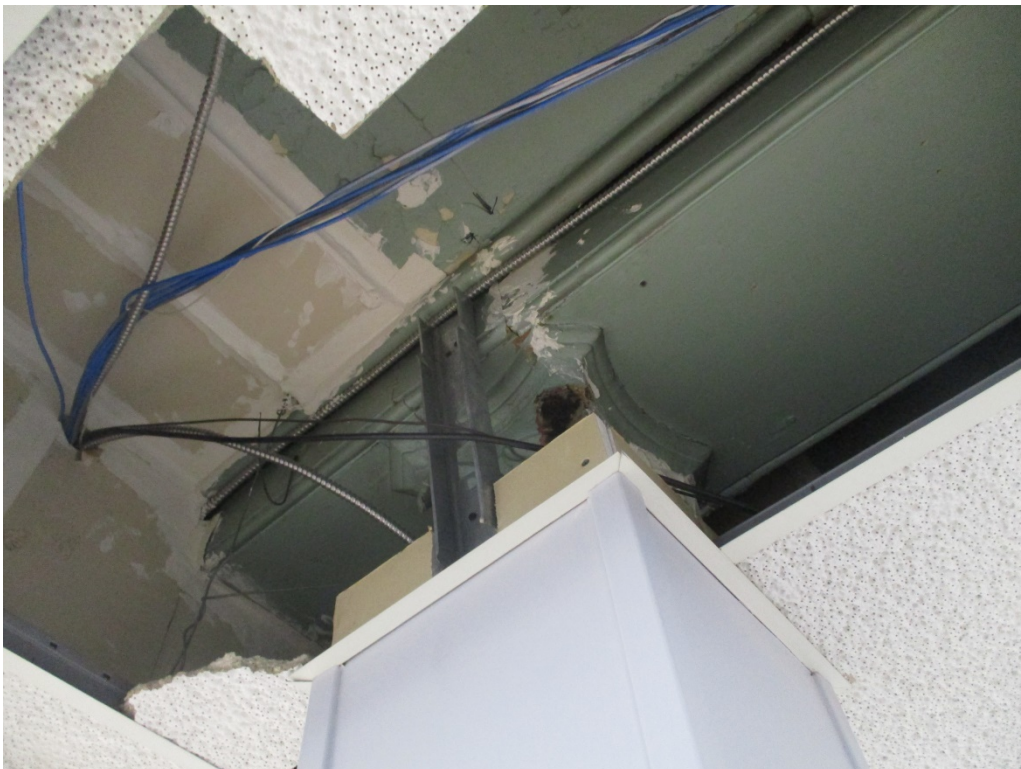
- LP01 – 2850 µg/g.

Therefore, LP01 collected on April 2, 2019 is considered lead containing, while LP05 collected on May 1, 2019 is classified as lead-based, and LP06 collected on May 1, 2019 is classified as lead-containing. The remaining samples are classified as low level lead-containing.

Photograph No. 2 – Green paint above ceiling tiles in the Basement area is lead-containing.

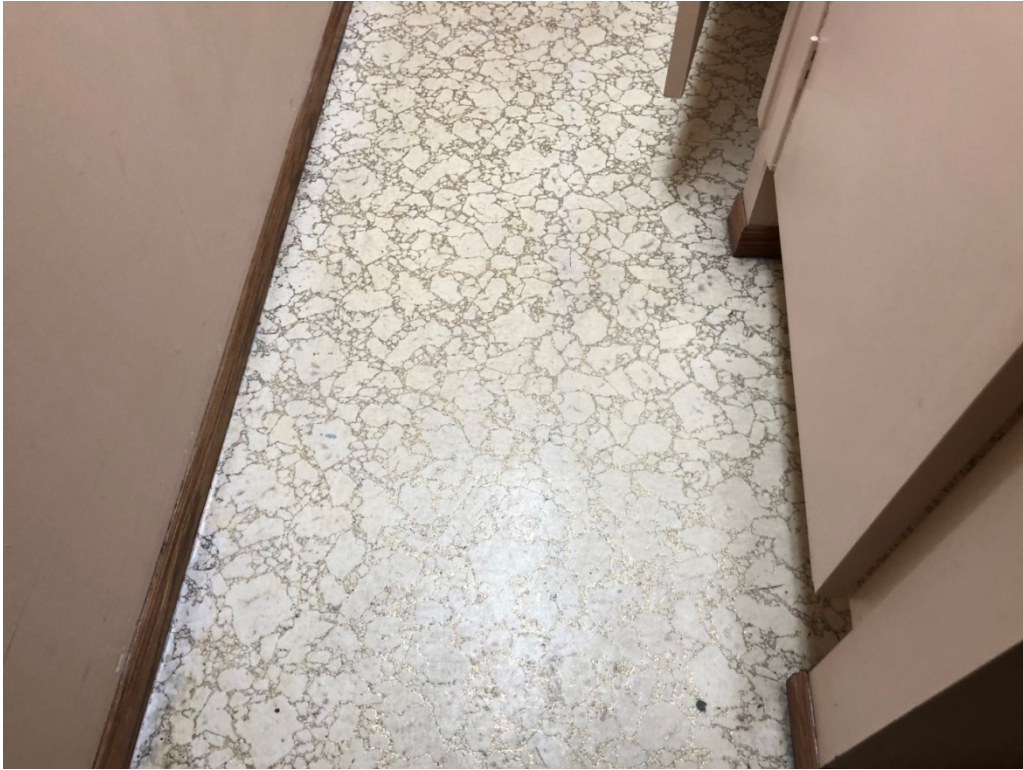
Photograph No. 3 – Vinyl sheet flooring within the foyer washrooms is asbestos-containing.

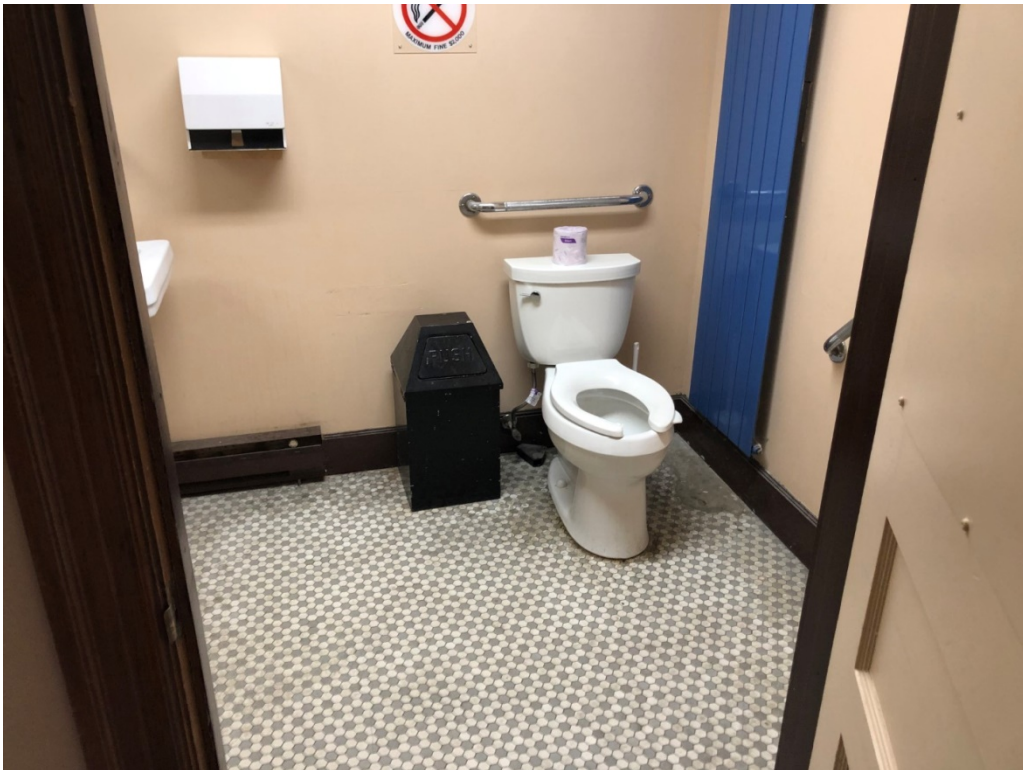
Photograph No. 4 – Beige paint in the foyer washrooms is lead-based.

Building finishes with the lead-based paint require analysis of Leachable Lead according to Ontario Regulation 558/00 prior to disposal, or they can be deemed hazardous. If determined hazardous, materials must then be manifested and disposed of off-site at a Ministry of Environment facility that is licensed to accept hazardous waste.

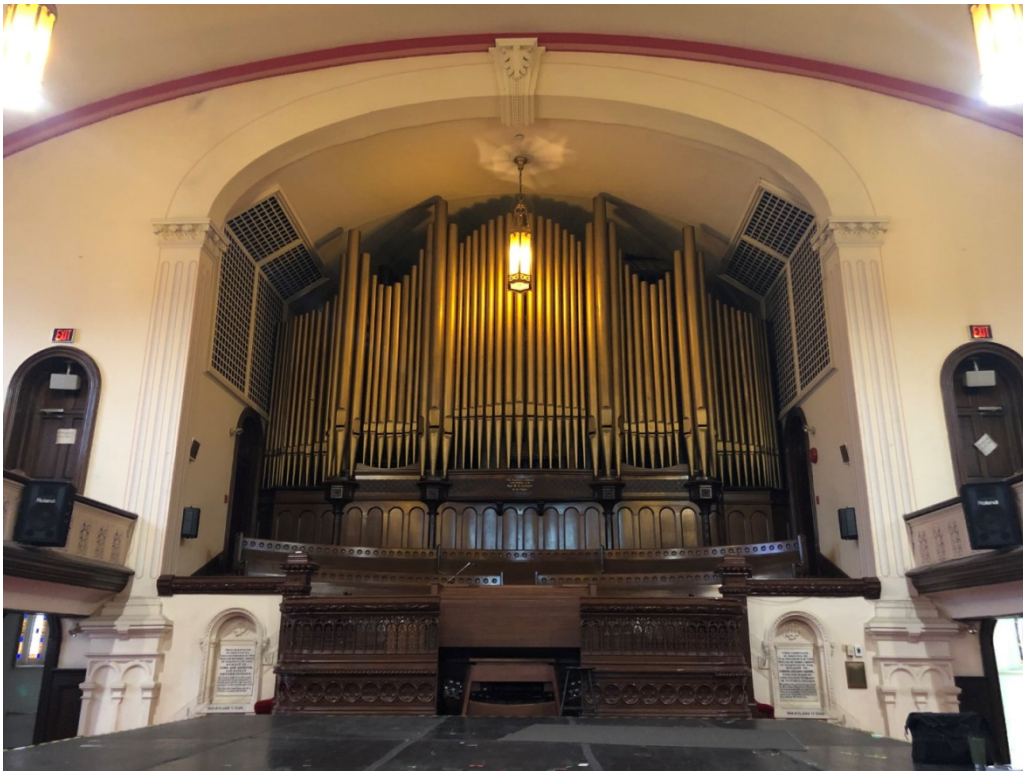
Photograph No. 5 – Cream paint within the Sanctuary us lead-containing.

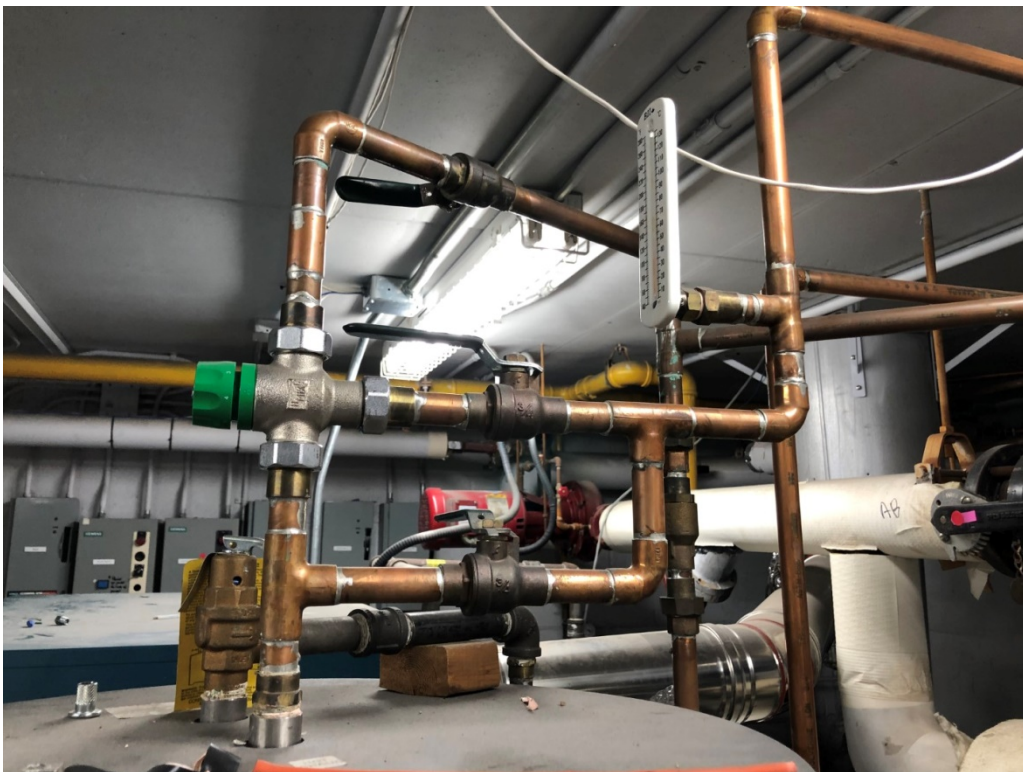
Solder on copper pipe connections were visually identified at the Site, and lead pipe gaskets may be concealed within the Site building.

Photograph No. 6 – Solder joints on copper pipes are suspected of containing lead.

Lead-based paint, lead-containing paint, lead-containing pipe gaskets, and lead-containing solder on plumbing connections were identified. As such special requirements for the management, handling and disposal of lead-containing materials by the owner, constructor, contractor, sub-contractors and workers apply. The abatement contractor should consult EACO's *Lead Guideline for Construction, Renovation, Maintenance or Repair (October 2014)* for the procedures and methods required to remove and dispose of lead-containing materials.

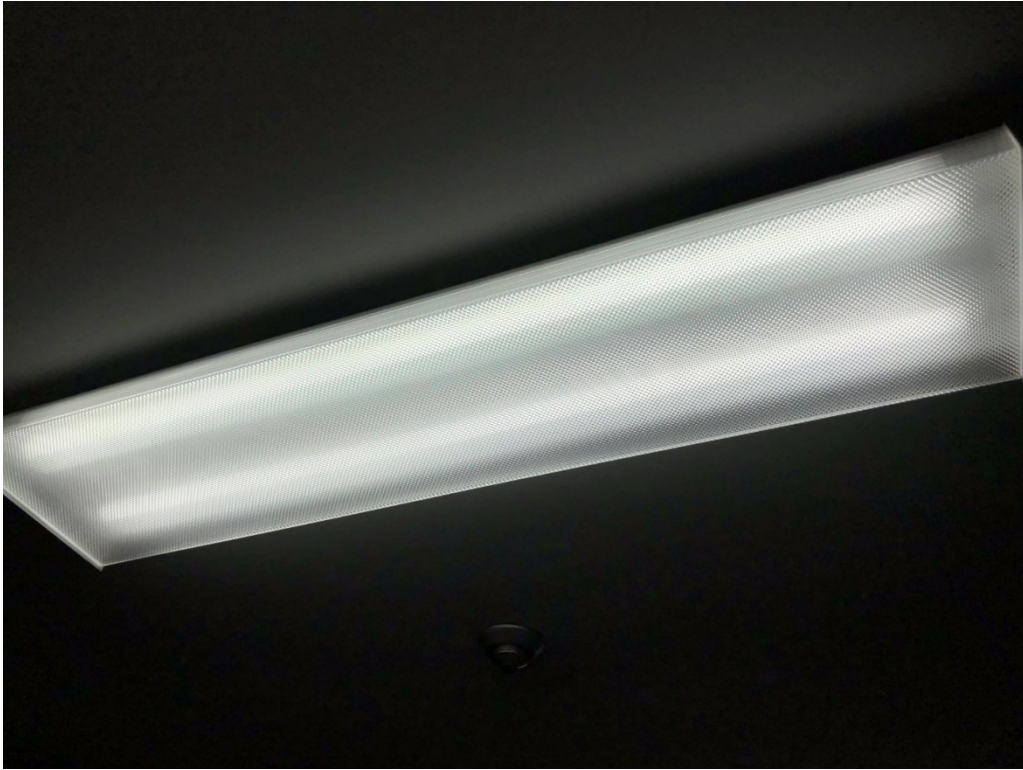
- Fluorescent light tubes; and
- Compact fluorescent bulbs.

Fluorescent light fixtures were observed at the Site, however; no light ballasts were inspected as all live electrical equipment that could not be properly and safely de-energized was not assessed. Light ballasts which were not accessed, will require additional investigation to determine their PCB content when removed from service.

Photograph No. 7 – Fluorescent light tubes are suspected of containing mercury, and florescent light ballasts are suspected of containing PCBs.

Mercury-containing fluorescent light tubes and fluorescent light bulbs were observed in fixtures. All mercury containing materials or sources should be removed, intact, prior to any work which may disturb or damage them and cause worker exposure to mercury liquid and/or vapour.

On-site crushing of mercury-containing materials should not occur. Care should be taken to ensure safe storage of the above until recycling or disposal can be coordinated. Under current legislation, mercury waste requires handling and disposal in accordance with Ontario Regulation 490/09 of the OHSA and Ontario Regulation 347 of the Environmental Protection Act.

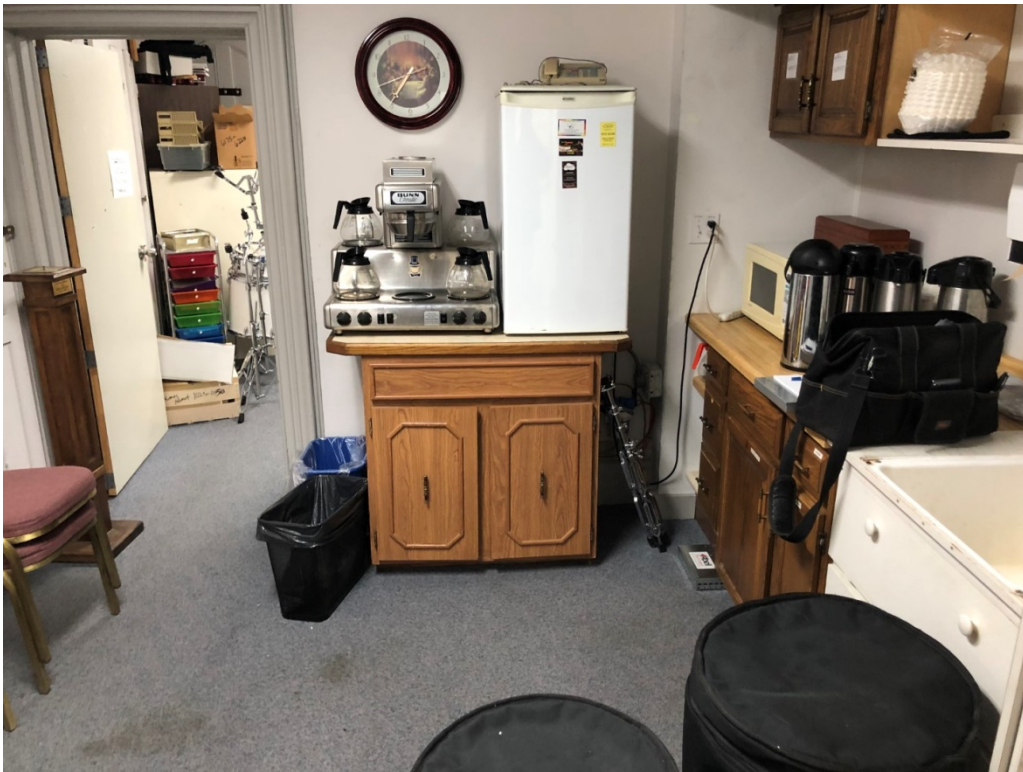
Refrigerator units were observed in the Kitchen and Servery areas of the site, and are suspected of containing ODS's.

Photograph No. 8 – Refrigeration units in the Servery and the Kitchen are suspected of containing ODS's.
