DESIGNATED SUBSTANCES SURVEY

**6th Floor
100 King St W.
Hamilton, Ontario**

April 29th, 2024

Designated Substance Survey
First Real Properties Limited
100 King St. W. Hamilton – 6th Floor

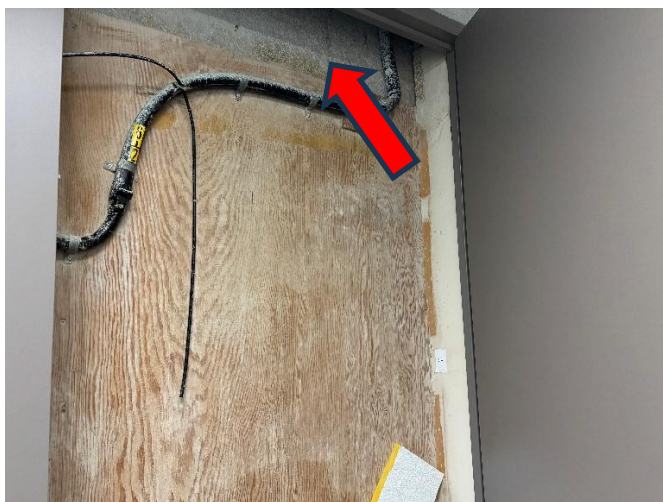
Sample #s	FP 1-3
ACM Description	Grey Sprayed on Fireproofing
Asbestos Content	5 -20% Chrysotile
Locations	Overspray in Closets,
Map Code

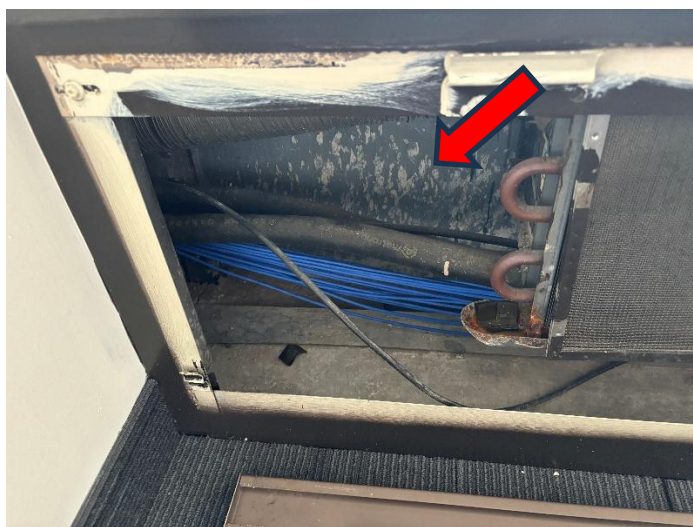
Sample #s	FP 1-3
ACM Description	Grey Sprayed on Fireproofing
Asbestos Content	5 - 20% Chrysotile
Picture Location	Overspray Perimeter Rads and Columns
Map Code

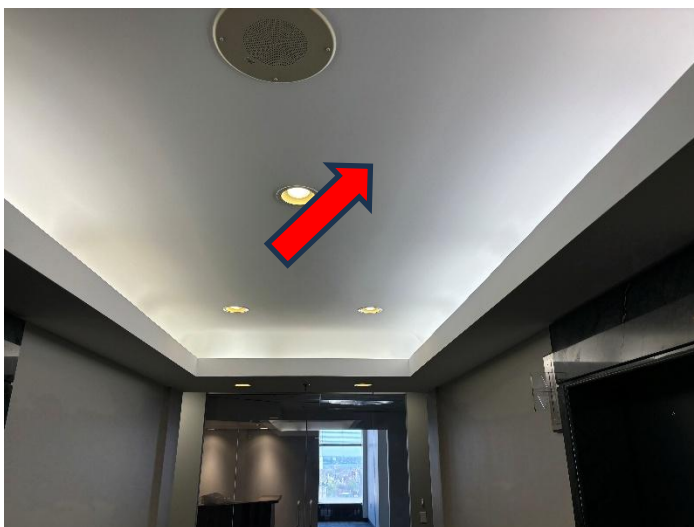
Drywall	
Sample #s	D 1-7
ACM Description	Drywall Joint Compound, Off- White
Asbestos Content	3% Chrysotile
Picture Location	Elevator Lobby
Map Code

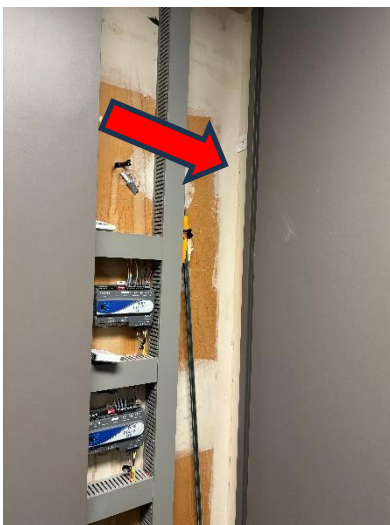
Drywall	
Sample #s	D 1-7
ACM Description	Drywall Joint Compound, Off - White
Asbestos Content	3% Chrysotile
Picture Location	Johnson Controls Closet
Map Code

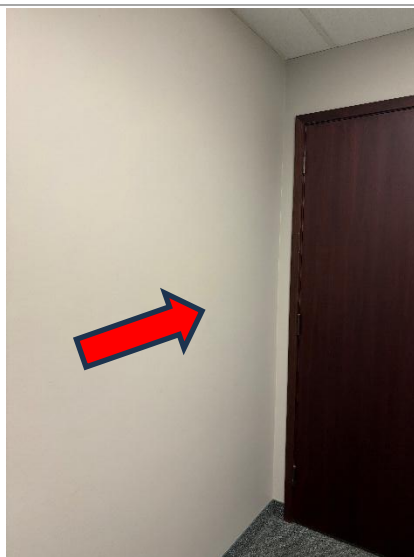
Drywall	
Sample #s	D 1-7
ACM Description	Drywall Joint Compound, Off White
Asbestos Content	3% Chrysotile
Picture Location	Hallway
Map Code

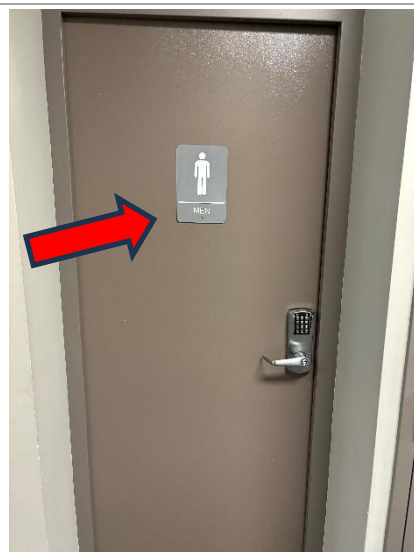
Bathroom Doors	
Sample #s	-
ACM Description	Bathroom Door with Asbestos within
Asbestos Content	Visually Confirmed
Picture Location	Washroom View from Hallway
Map Code

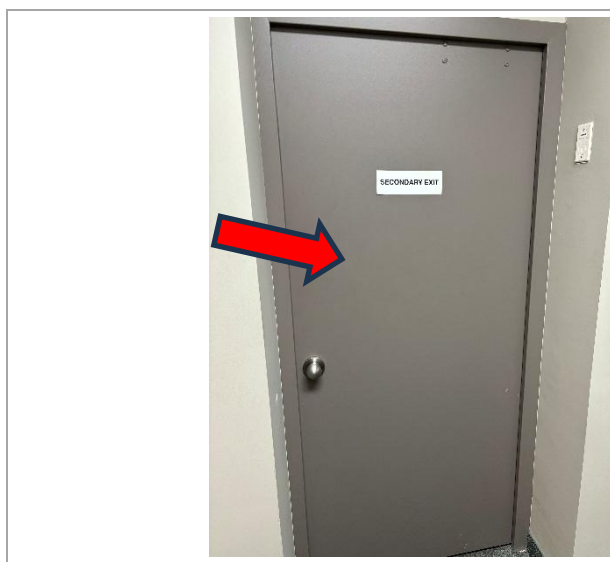
Stairwell Doors

Sample #s	-
ACM Description	Stairwell Door(s) With Asbestos within
Asbestos Content	Visually Confirmed
Picture Location	South Stairwell
Map Code

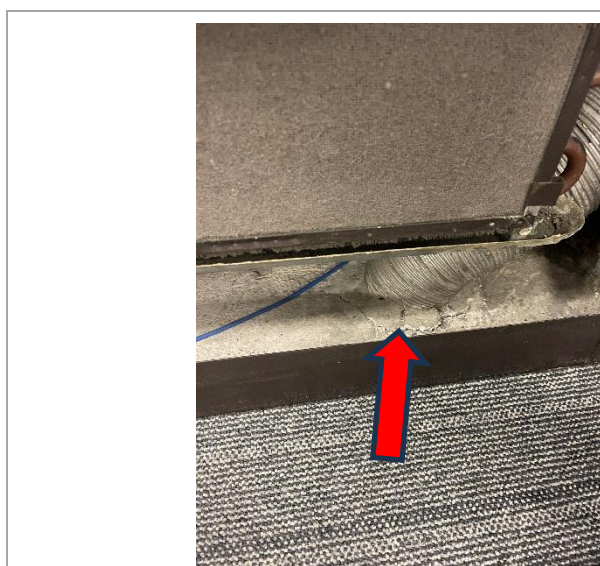
Parging

Sample #s	P-1
ACM Description	Induction unit dependable IT
Asbestos Content	Visually Confirmed
Picture Location	South Stairwell Door view from Office Space
Map Code
