## **Hazardous Building Materials Assessment (Pre-construction)**

Roof Replacement  
St. Margaret Mary Catholic  
Elementary School  
25 Brentwood Drive, Hamilton,  
Ontario

April 9, 2026

Pinchin File: 368268.001

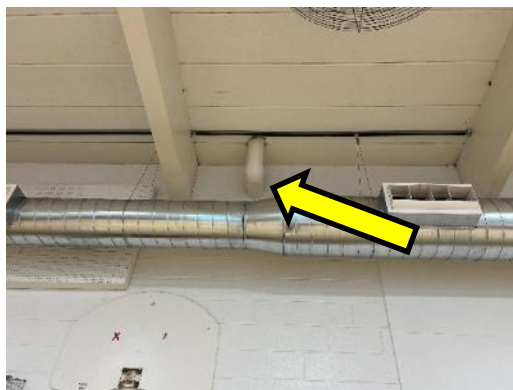
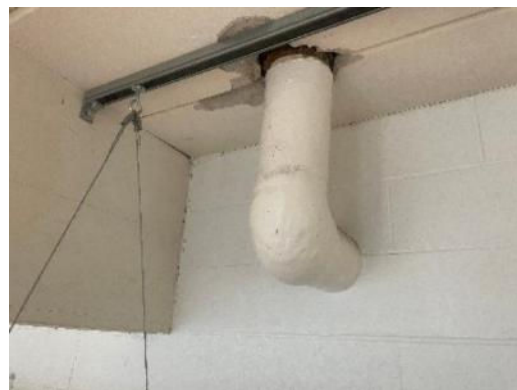
Pipe straight sections are insulated with non-asbestos fibreglass.

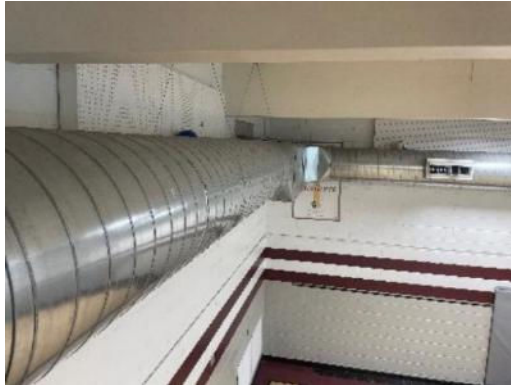
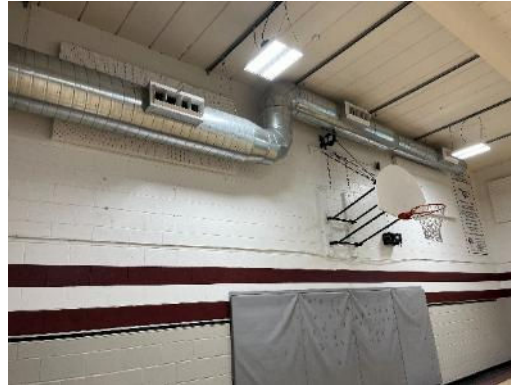
Ducts are uninsulated (photos 1 and 2).

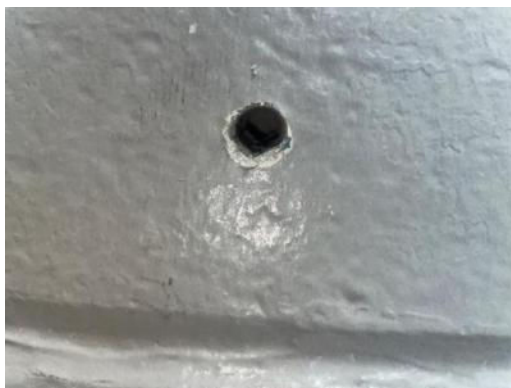
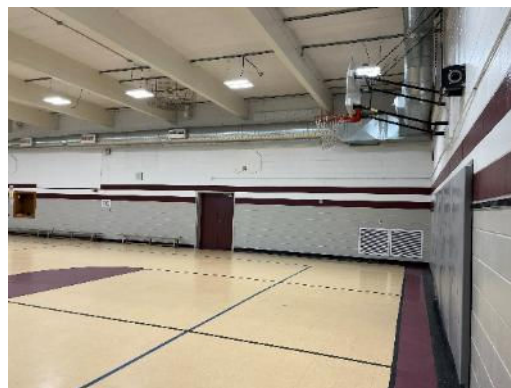
Destructive testing was conducted of a representative selection of masonry block walls, including creating penetrations at four locations. The locations of destructive testing have been indicated on the drawings in Appendix I.

Loose fill vermiculite was not observed within the cavities (photos 1 and 2).

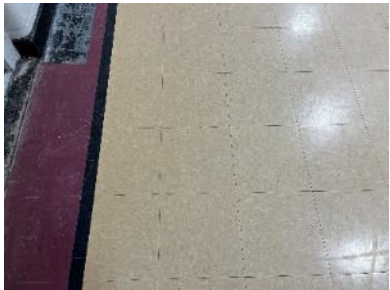
Description	Sample Location (Location #)	Sample Number	Asbestos (Tile / Adhesive)	Photo
12" x 12", beige with light and dark smears and 12" burgundy*	Gymnasium (Location 1037)	V0000 S0013	No / No

Vinyl floor tiles were presumed to be non-asbestos based on historical knowledge of the date of installation (post-1992).

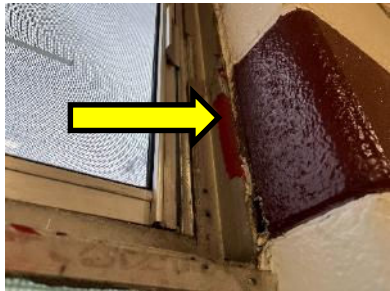
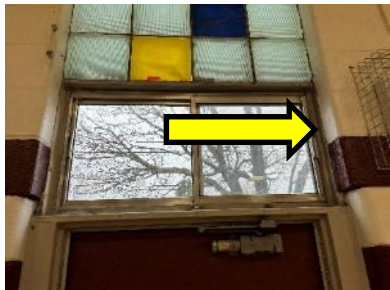
Material, Description and Application	Sample Location (Location #)	Sample Number	Asbestos	Photo
Caulking at window frame	Gymnasium (Location 1037)	S0008A-C	Yes

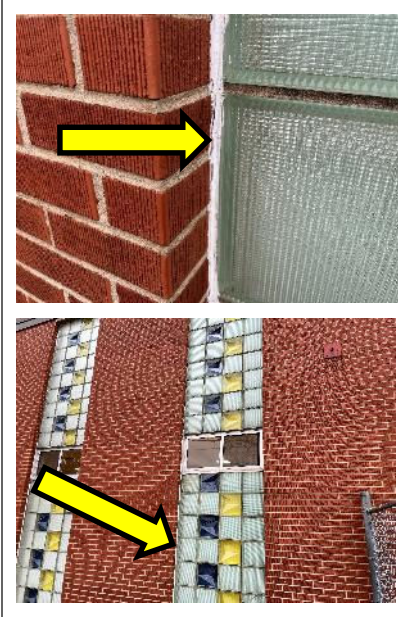
Material, Description and Application	Sample Location (Location #)	Sample Number	Asbestos	Photo
Caulking at exterior window frame and glass block	Exterior (Location 1000)	S0009A-C	Yes

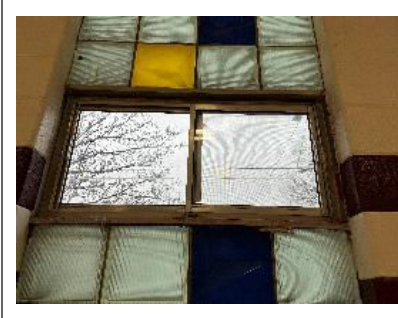
Caulking at glass block windows	Gymnasium (Location 1037)	S0014A-C	No

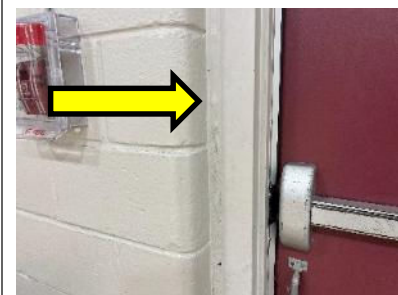
Door caulking	Gymnasium (Location 1037)	S0015A-C	No

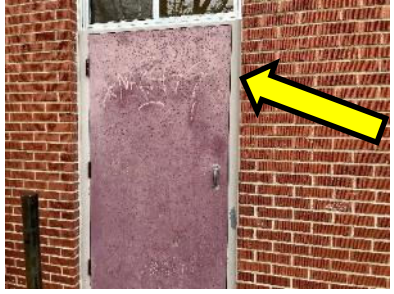
Material, Description and Application	Sample Location (Location #)	Sample Number	Asbestos	Photo
Exterior door caulking	Exterior (Location 1000)	S0016A-C	No

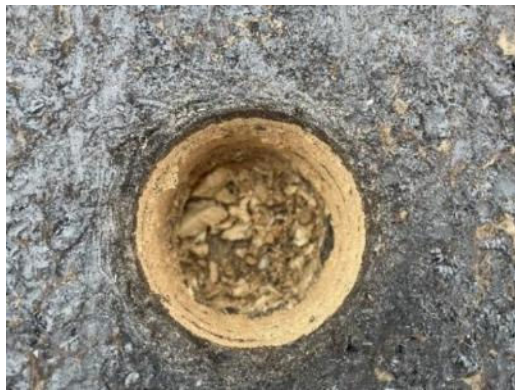
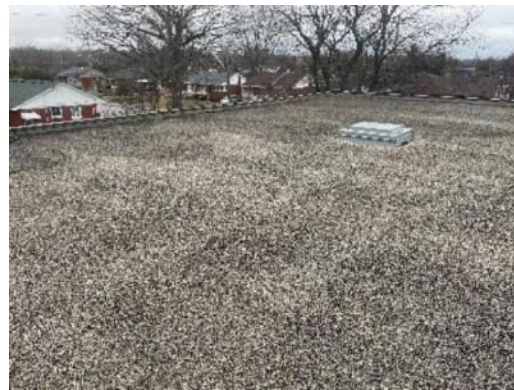
The materials associated with the roofing do not contain asbestos (samples S0005A-C, photos 1 and 2).

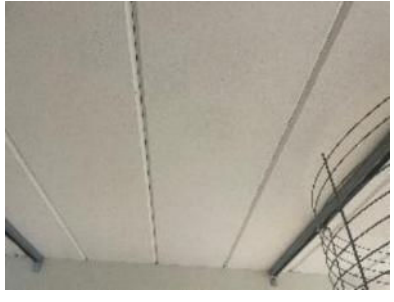
Description	Sample Location (Location #)	Sample Number	Asbestos	Photo
Siporex decking	Gymnasium (Location 1037)	S0007A-C	No

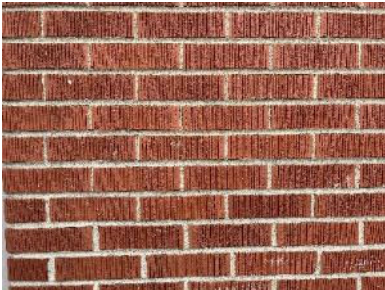
Description	Sample Location (Location #)	Sample Number	Asbestos	Photo
Exterior brick mortar	Exterior (Location 1000)	S0010A-C	No

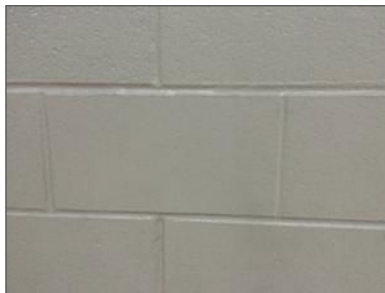
Concrete block mortar	Gymnasium (Location 1037)	S0011A-C	No

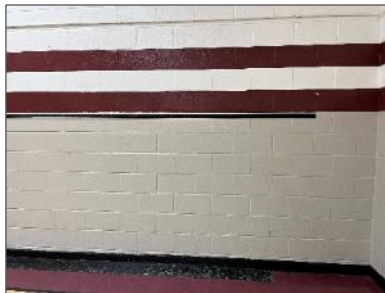
Concrete block paint	Gymnasium (Location 1037)	S0012A-C	No

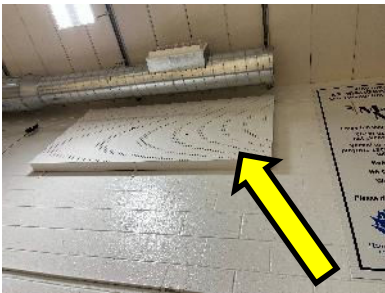
Wood acoustic panels	Gymnasium (Location 1037)	V0000	No

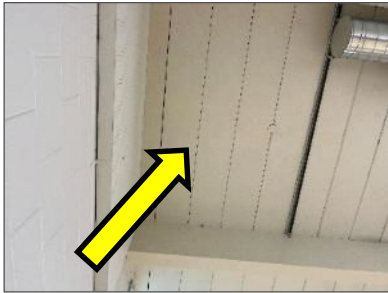
Sample Number	Colour, Substrate Description	Sample Location	Lead (%)	Photo
L0001	Paint on Siporex decking	Gymnasium (Location 1037)	0.0016

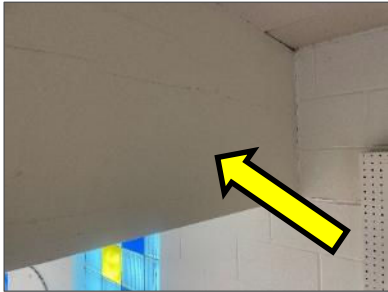
L0002	Paint on wood beam	Gymnasium (Location 1037)	0.048

For paints identified as having low levels of lead (i.e., greater than 0.009% (90 mg/kg) but less than or equal to the EACC guideline of 0.1% (1,000 mg/kg) for lead-containing paints) special precautions are not recommended unless aggressive disturbance (grinding, blasting, torching) is planned.

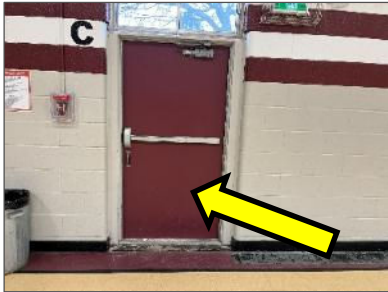
Sample Number	Colour, Substrate Description	Sample Location	Lead (%)	Photo
L0003	Red on metal door	Gymnasium (Location 1037)	0.00078

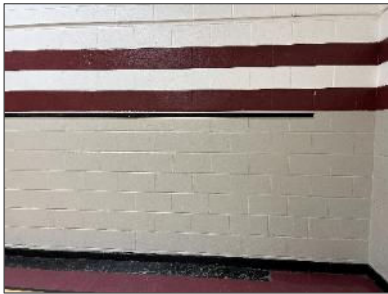
L0004	Grey on concrete block	Gymnasium (Location 1037)	0.19

Results above 0.1% (1,000 mg/kg) are considered lead-containing, and over 0.5% (5,000 mg/kg) are considered lead-based in accordance with the EACC guideline.

Items painted with paints containing elevated levels of lead may be a hazardous waste. Test lead-painted materials for leachable lead and other metals prior to disposal. Metallic components coated with lead paint do not require leachate testing and can be disposed of as non-hazardous construction and demolition (C&D) waste.

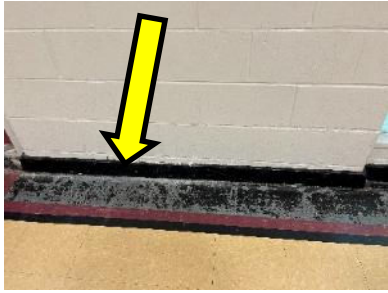
L0005	Black on wood baseboard	Gymnasium (Location 1037)	0.19

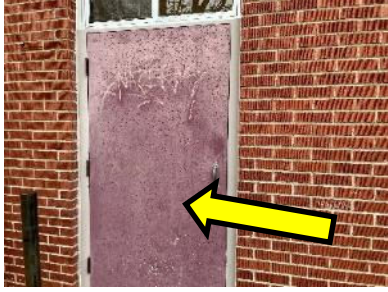
L0006	Paint on exterior door	Exterior (Location 1000)	0.00062

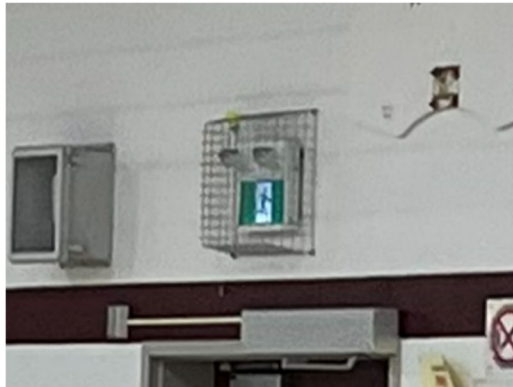
Photo 1

Lead-containing batteries are present in emergency lighting (photo 1).
