Asbestos Assessment

St. Margaret Mary
25 Brentwood Drive, Hamilton, ON,
L8T 3V9

**Hamilton-Wentworth Catholic
District School Board**

Updated: July 11, 2025

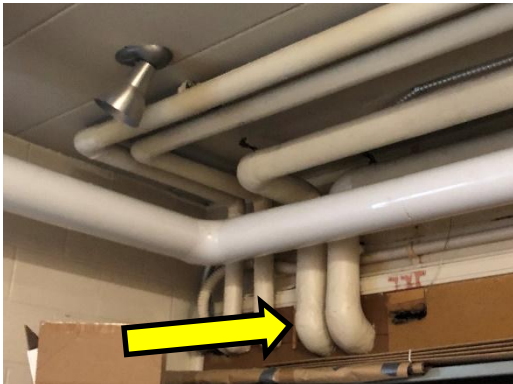
Material and Application	Asbestos Type	Photo
<p>Parging cement is present on pipe fittings (elbows, valves, tees, hangers etc.).</p>	<p>Chrysotile</p>

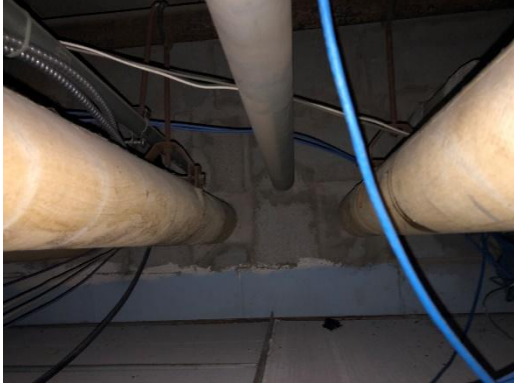
Material and Application	Asbestos Type	Photo
<p>A white corrugated paper insulation (trade name Aircell) is present on straight sections of pipes.</p>	<p>Chrysotile</p>

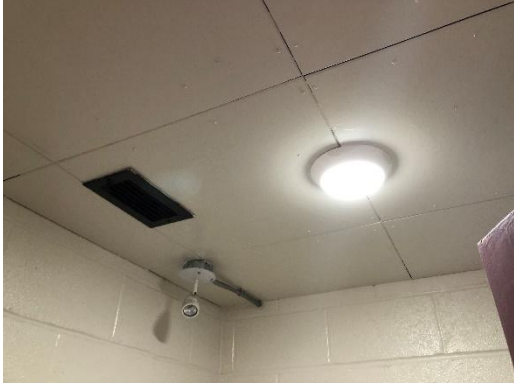
Material and Application	Asbestos Type	Photo
<p>Transite board is present as a ceiling finish and as acoustic wall panels.</p>	<p>Presumed</p>

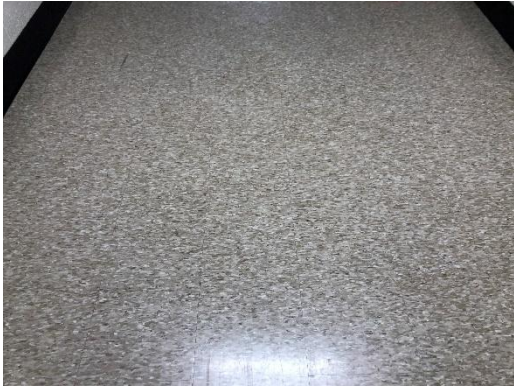
<p>Vinyl floor tiles, 12"x12", light grey multi-fleck, are present.</p>	<p>Presumed (tile) Presumed (mastic)</p>

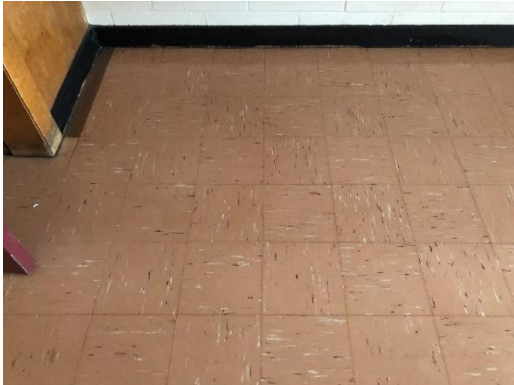
<p>Vinyl floor tiles, 9"x9", pink with white and brown streak, are present.</p>	<p>Presumed (tile) Presumed (mastic)</p>

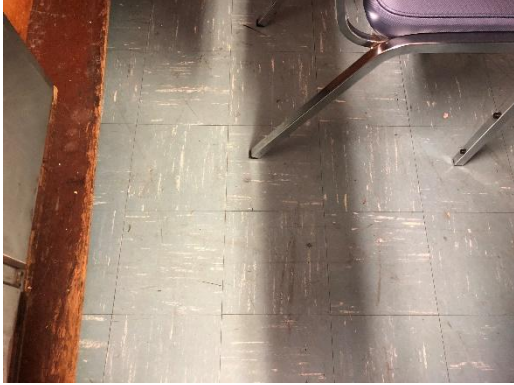
Material and Application	Asbestos Type	Photo
<p>Vinyl floor tiles, 9"x9", green with white streaks, are present.</p>	<p>Presumed (tile) Presumed (mastic)</p>

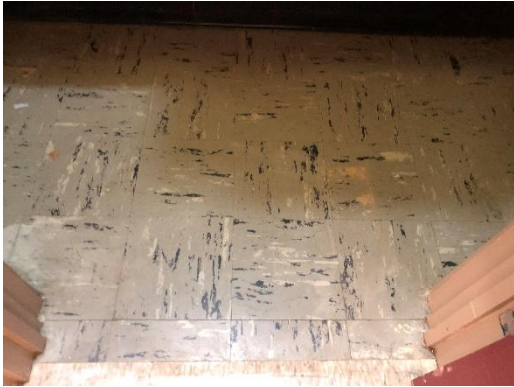
<p>Vinyl floor tiles, 9"x9", grey with white and black streaks, are present.</p>	<p>Presumed (tile) Presumed (mastic)</p>

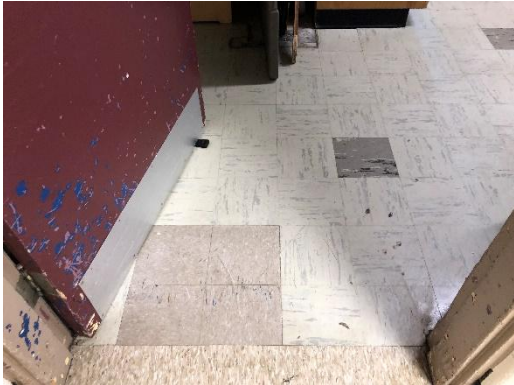
<p>Vinyl floor tiles, 9"x9", white with grey streaks, are present.</p>	<p>Presumed (tile) Presumed (mastic)</p>

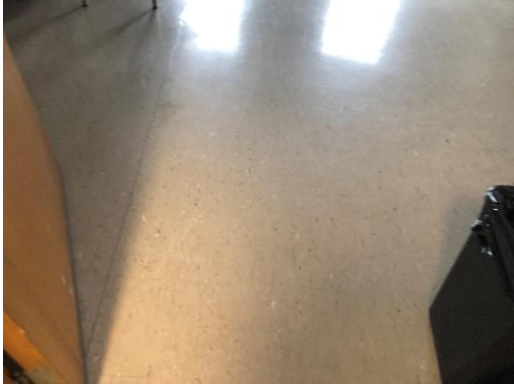
Material and Application	Asbestos Type	Photo
<p>Vinyl floor tiles, 12"x12", brown with white and black streaks, are present.</p>	<p>Presumed (tile) Presumed (mastic)</p>

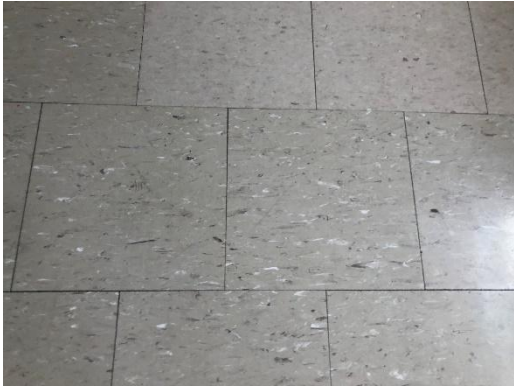
<p>Vinyl floor tiles, 12"x12", grey with white and black streaks, are present.</p>	<p>Presumed (tile) Presumed (mastic)</p>

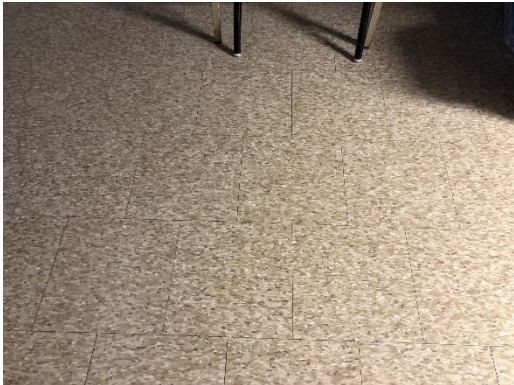
<p>Remaining vinyl floor tiles are presumed to be non-asbestos based on historical knowledge of the date of installation.</p> <p>Mastic under non-asbestos tiles is presumed to contain asbestos until further sampling is performed.</p>	<p>None (tile) Presumed (mastic)</p>

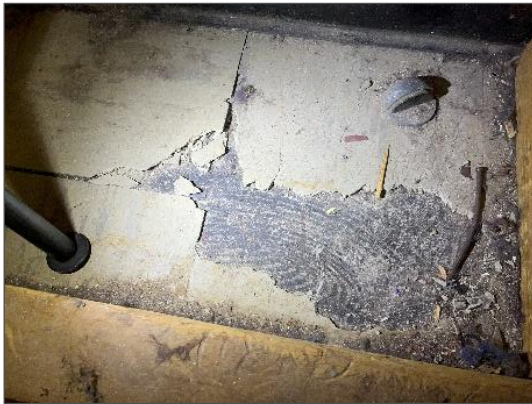
Material, Quantity, Condition, Photo #	Location (Location #)	Recommended Procedure
Vinyl floor tiles, poor, 2 SF, Photo 1	Supply Room (Location 1035)	Removal in accordance with Type 1 asbestos abatement procedures.
