## **Hazardous Building Materials Assessment (Pre-construction)**

New Elevator Project  
St. Jean de Brébeuf Catholic  
Secondary School  
200 Acadia Drive, Hamilton,  
Ontario

May 5, 2026

Pinchin File: 368268.009

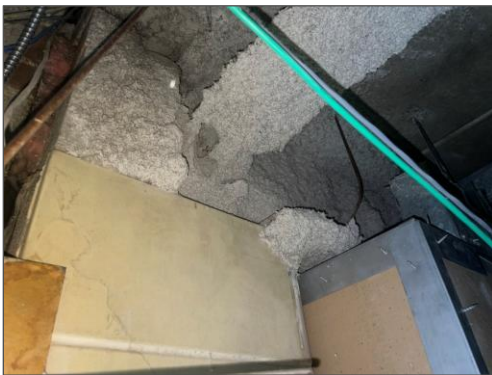
Spray-applied fireproofing and overspray present on the structure in the assessed area does not contain asbestos (samples S0057A-D, and AMEC-12A-G, Feb 12/09).

Non-asbestos grey fireproofing S0057A-C, Hallway (Loc. 1011)

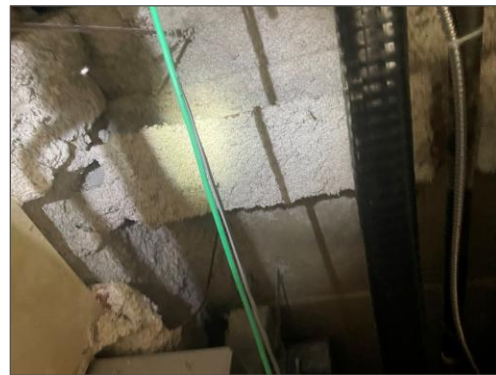
Non-asbestos grey fireproofing S0057A-C, Hallway (Loc. 2029)

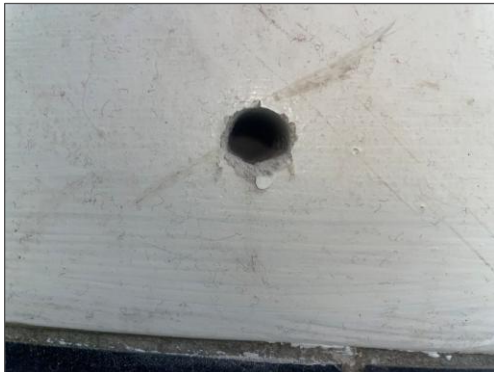
Loose fill vermiculite was not observed within the cavity.

Vermiculite investigation hole, no vermiculite found.

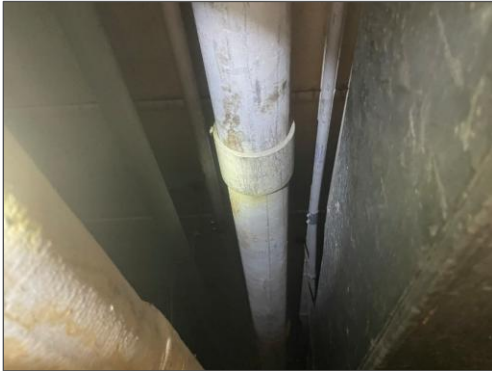
Cement pipe (Transite), presumed to contain asbestos based on visual observation, is present as sanitary drains rainwater leaders in the assessed area.

Presumed asbestos-containing transite pipe, Hallway (Loc. 1011)

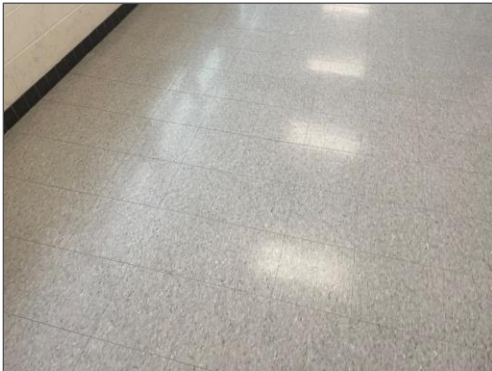
Non-asbestos 12"x12" vinyl floor tile, with asbestos-containing mastic S0059A-C, Hallway (Loc. 2029)

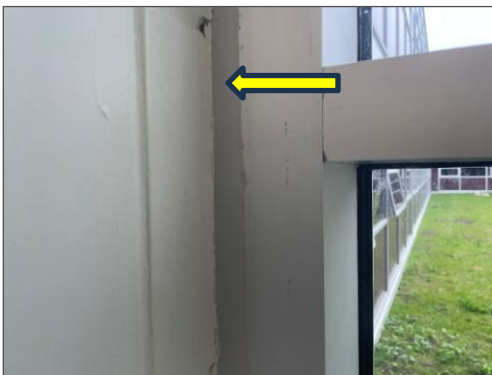
Non-asbestos grey caulking, S0052A-C, Hallway (Loc. 1011)

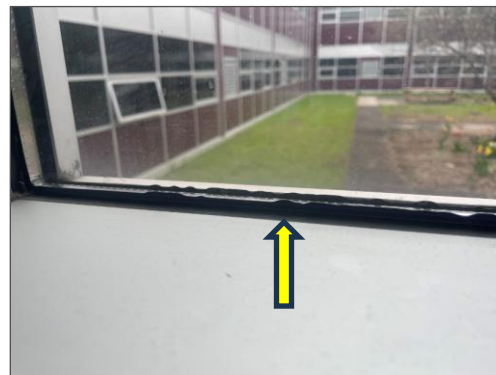
Black putty on the glass and frames of metal window frames does not contain asbestos (samples S0055A-C).

Non-asbestos black window putty, S0055A-C, Hallway (Loc. 1011)

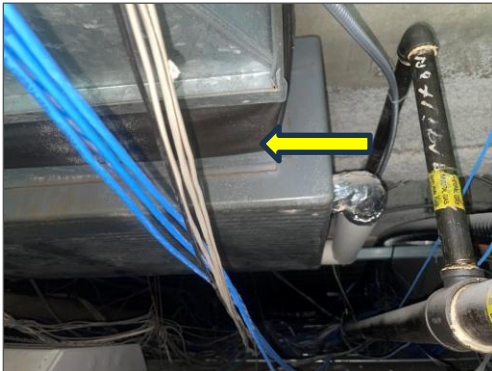
Textile vibration dampers, present as duct connectors in the assessed area, are non-asbestos (samples S0056A-C).

Non-asbestos vibration dampener textile, S0056A-C, Hallway  
(Loc. 1011)

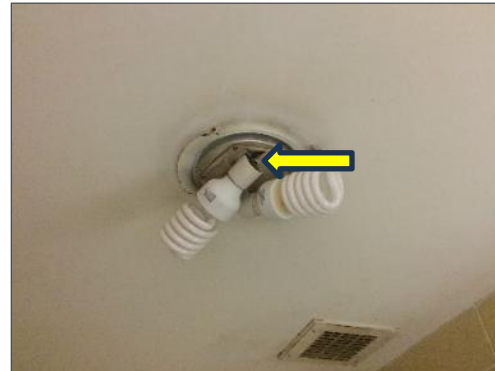
Paper heat shields, containing asbestos, are present within incandescent light fixtures in the Storage (Loc. 2045) (samples AMEC-16, Feb 12/09).

Asbestos-containing heat shield, Storage (Loc. 2045)

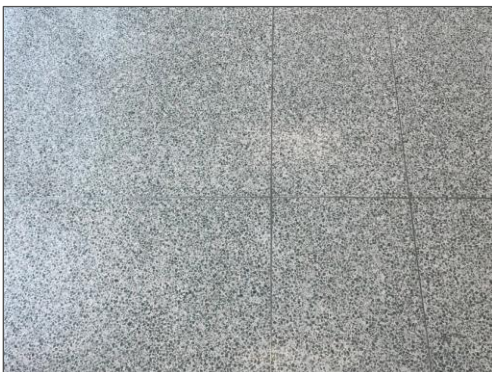
Green and white terrazzo is non asbestos containing, located in the Hallway (Loc. 1011) (samples S0053A-C).

Non-asbestos green and white terrazzo, S0053 Hallway (Loc. 1011)

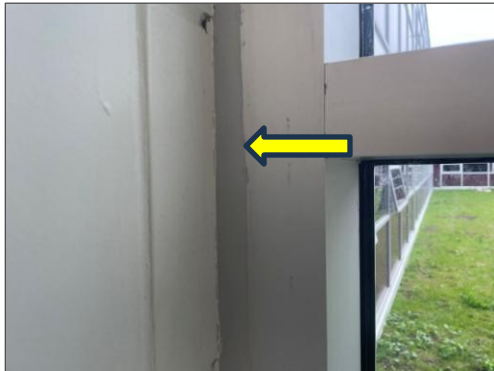
Grey caulking is present at window and door frames (sample P0001) and contains <0.2 mg/kg PCBs. The material is a non-PCB solid based on the threshold (50 mg/kg).

Non-PCB grey caulking, Hallway (Loc. 1011)
