**Re:**               **Hazardous Building Materials Assessment (Preconstruction)**  
Accessibility Upgrades Project  
Norwood Park Elementary School, 165 Terrace Drive, Hamilton, ON  
Pinchin File: 352293.011

Hamilton-Wentworth District School Board (Client) retained Pinchin Ltd. (Pinchin) to conduct a hazardous building materials assessment of Norwood Park Elementary School located at 165 Terrace Drive, Hamilton, ON.

The objective of the assessment was to identify specified hazardous building materials in preparation for building renovation activities. The proposed work as identified by the Client includes renovations to repurpose rooms for the construction of an elevator shaft.

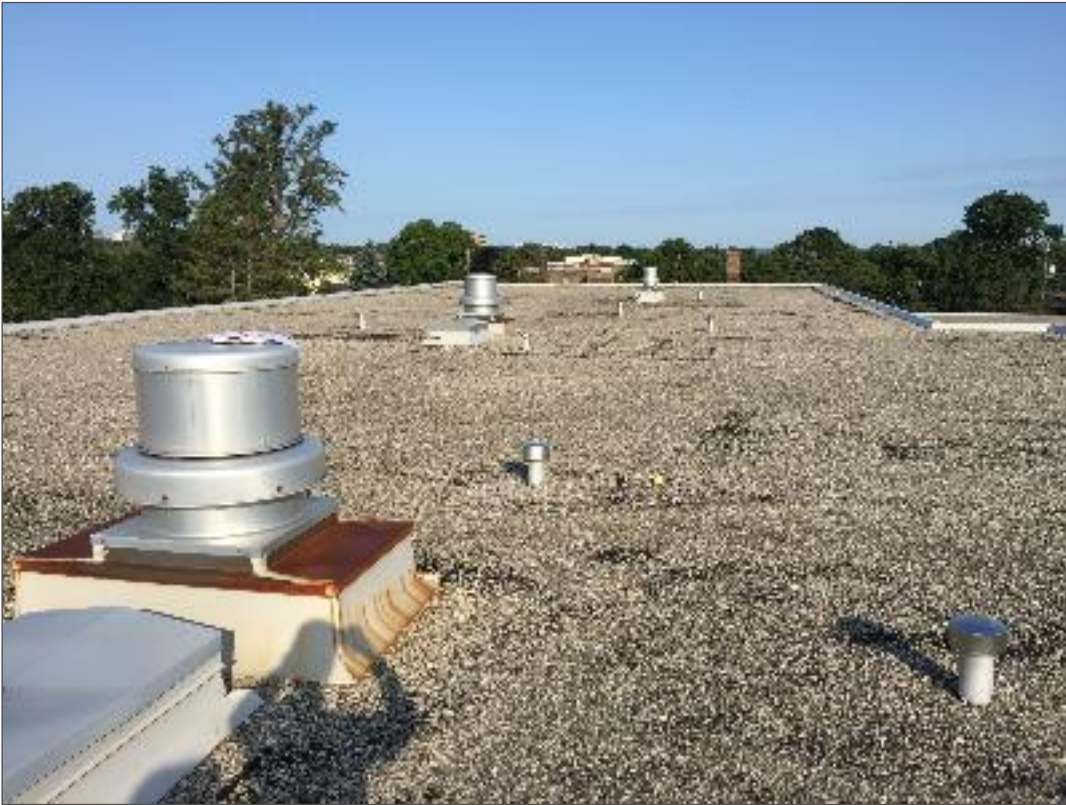
S0001A-C (None), Other, Roofing Materials, Roof / Exterior (Location #: 0) – (Photo from previous report)

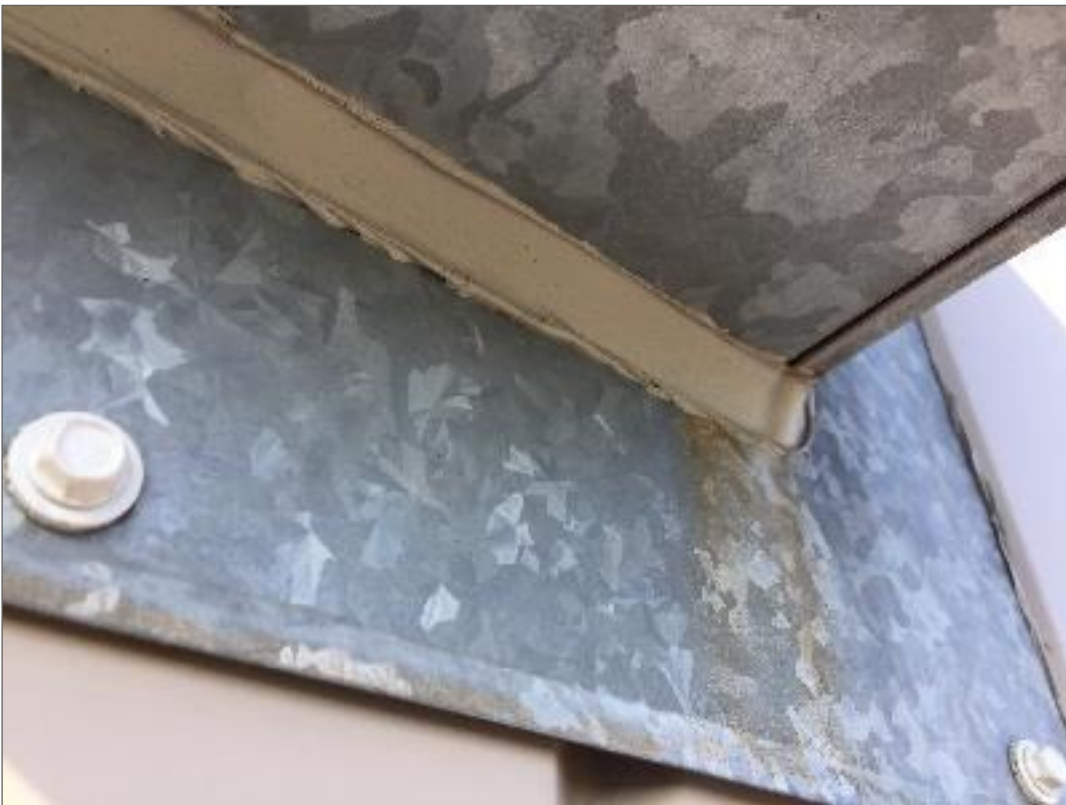
S0002A-C (Confirmed Asbestos ), Other, Caulking, Roof / Exterior (Location #: 0) (Photo from previous report)

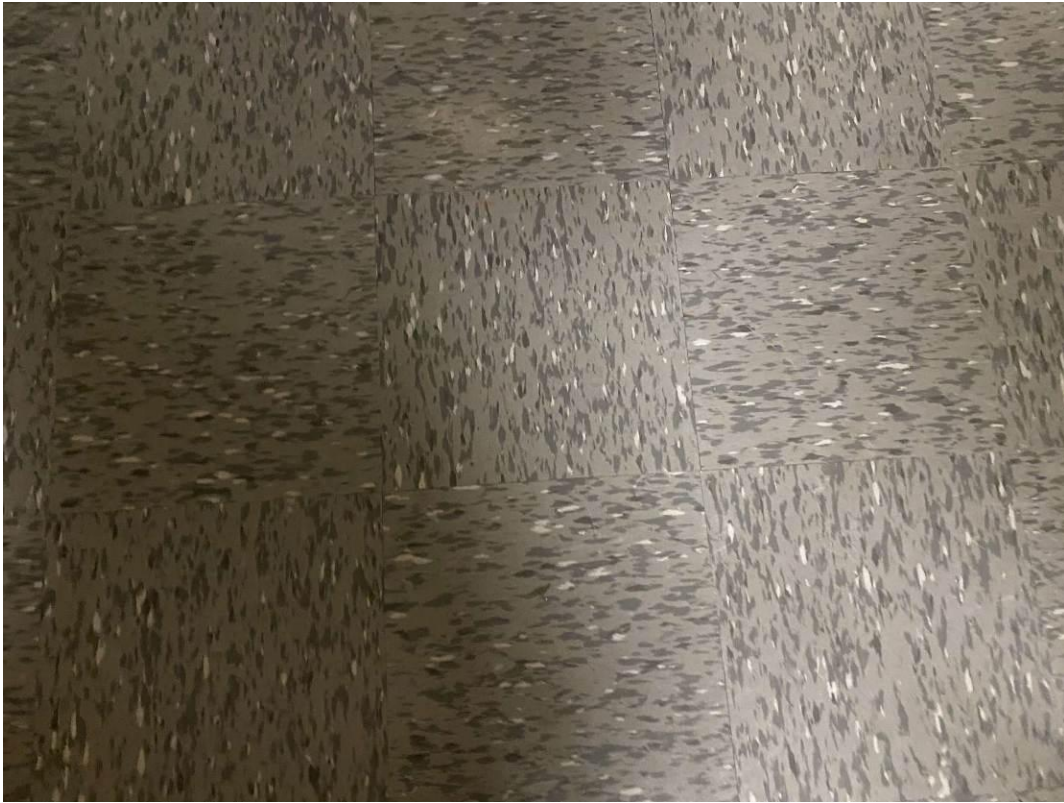
S0003A (Confirmed Asbestos), 12 x 12 grey with dark grey and white, Floor, All, Vinyl Floor Tile and Mastic, Learning Commons (Location #: 2972)

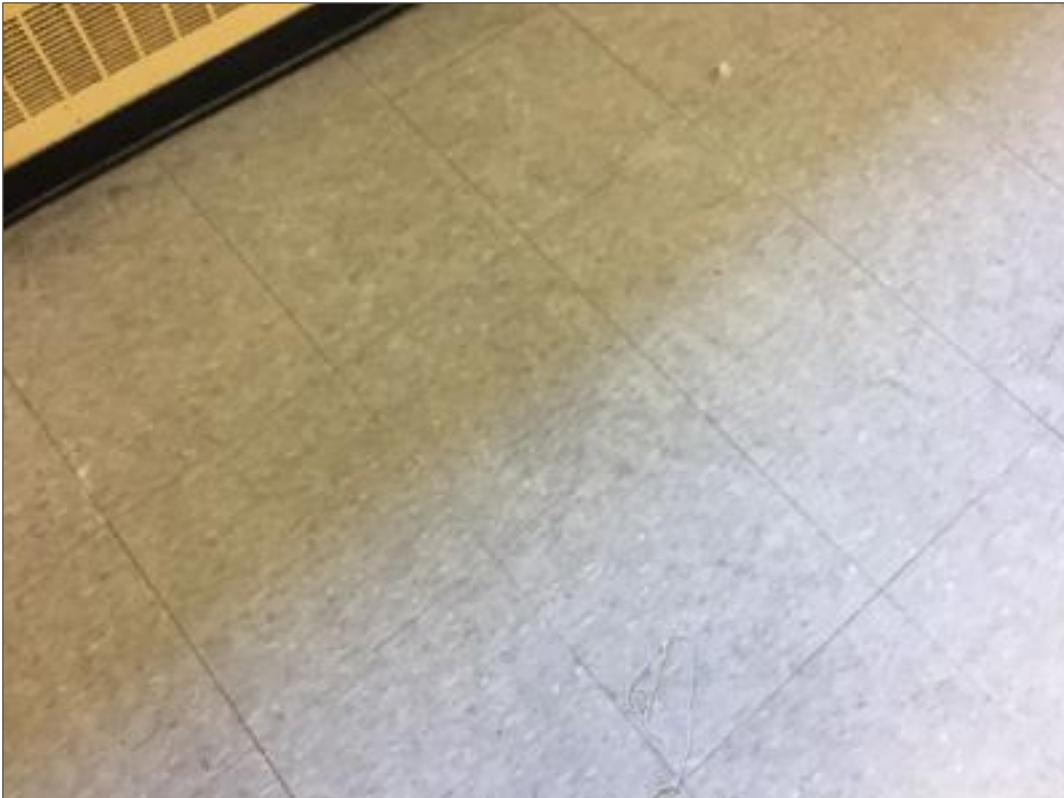
S0004A (Confirmed Asbestos), 12 x 12 grey with white fleck, Floor, All, Vinyl Floor Tile and Mastic, Learning Commons (Location #: 2972)

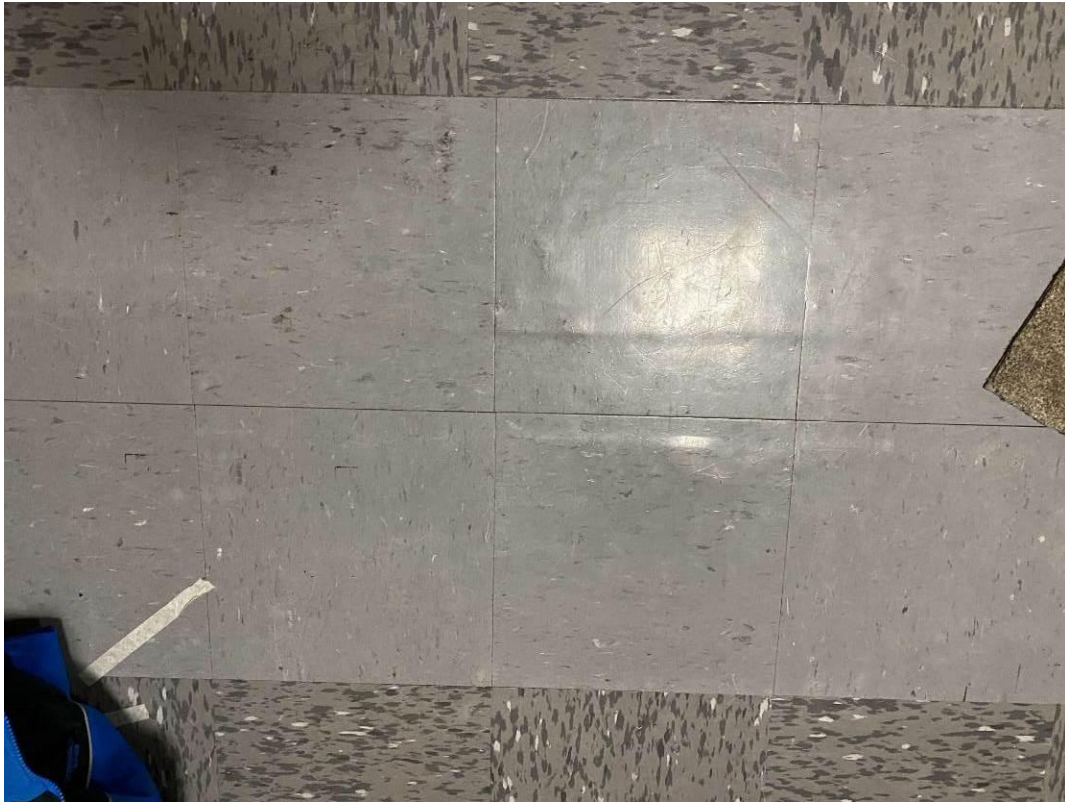
S0007A (Confirmed Asbestos), grey, Floor, Vinyl Floor Tile and Mastic, Learning Commons (Location #: 2972)  
Under millwork

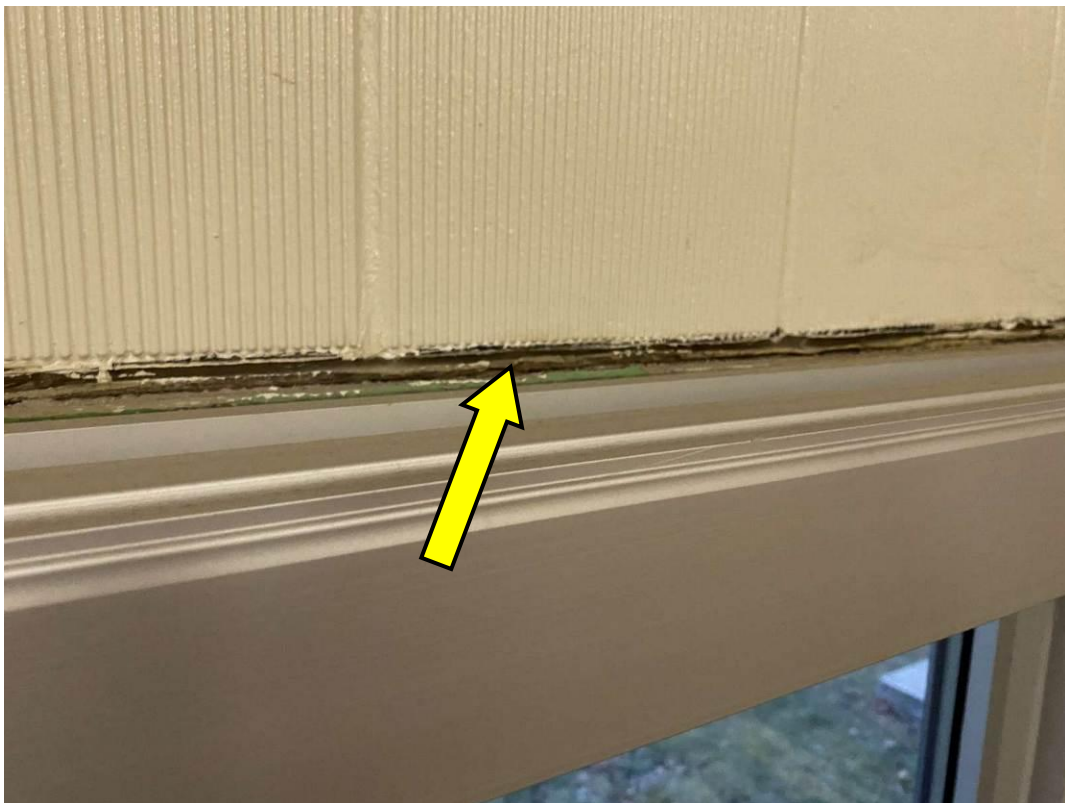
S0006A (Confirmed Asbestos), Other, Caulking, Learning Commons (Location #: 2972)  
White caulking on glass blocks

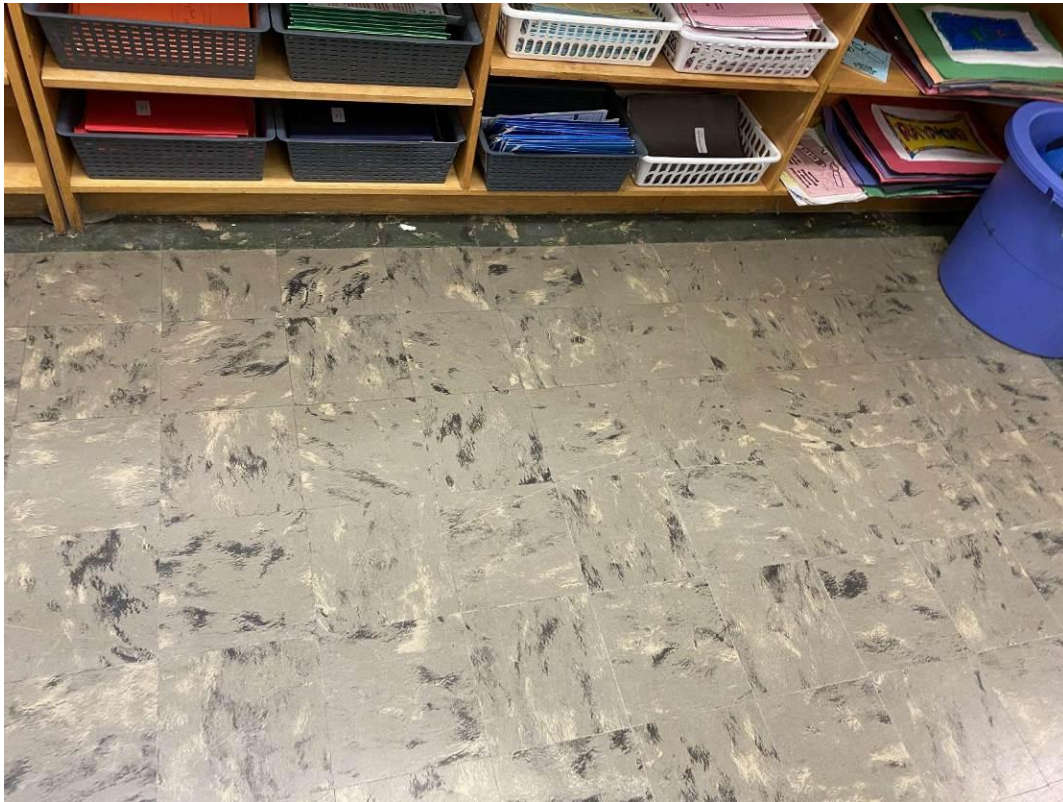
S0015 (Confirmed Asbestos), 9 x 9 grey with black and beige, Floor, Vinyl Floor Tile and Mastic, Classroom (Location #: 2991)

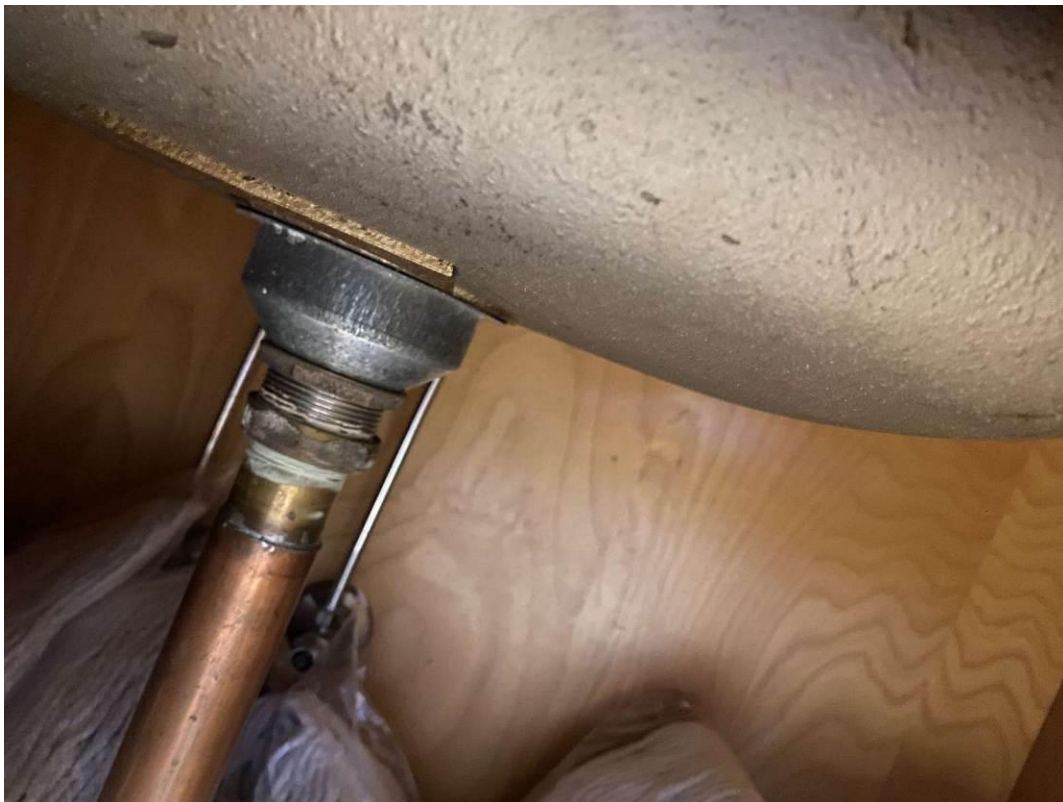
V0016 (Confirmed Asbestos), Other, Sink, Mastic, Gold, Classroom (Location #: 2995)

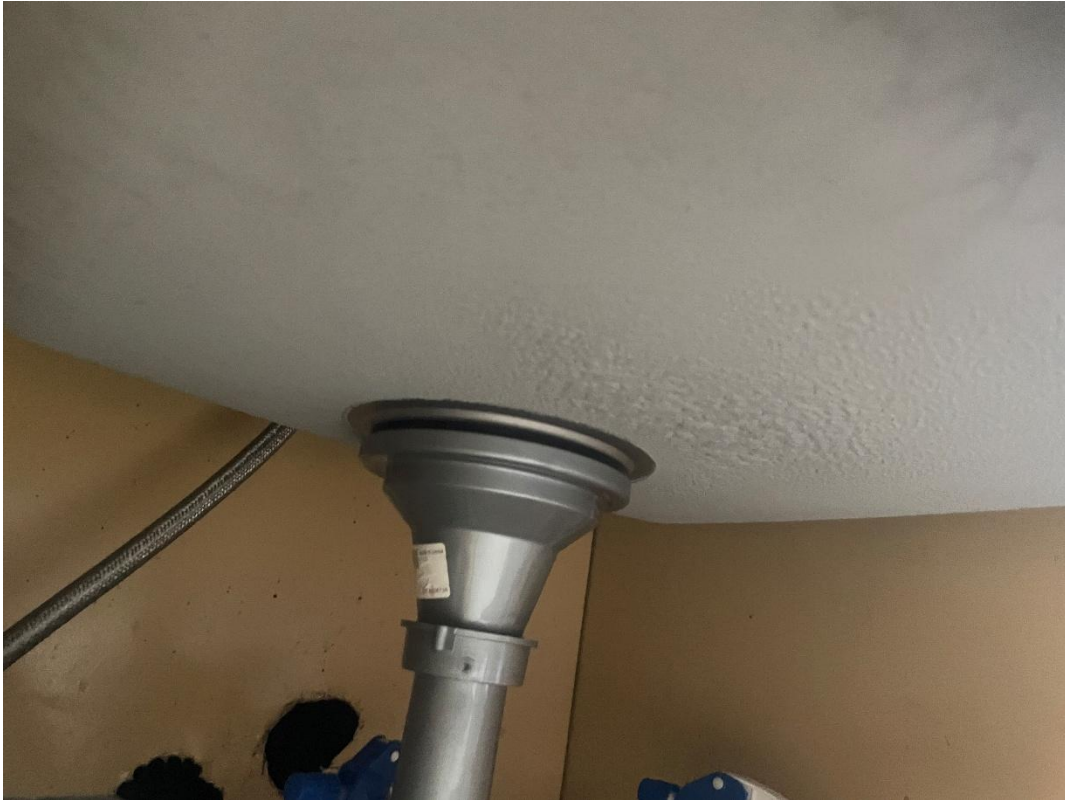
S0010A (None), Other, Sink, Mastic, White, Classroom (Location #: 2972)

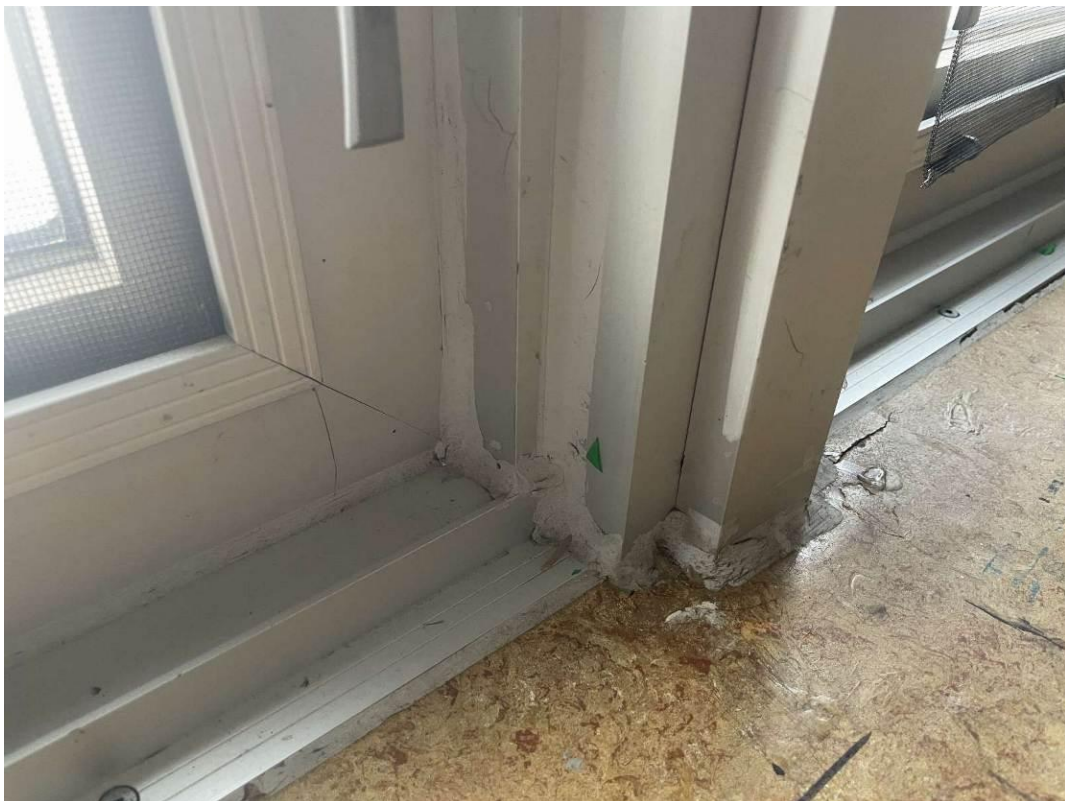
V0021 (None), Light grey caulking on windows, Other, Caulking, Classroom (Location #: 2993)

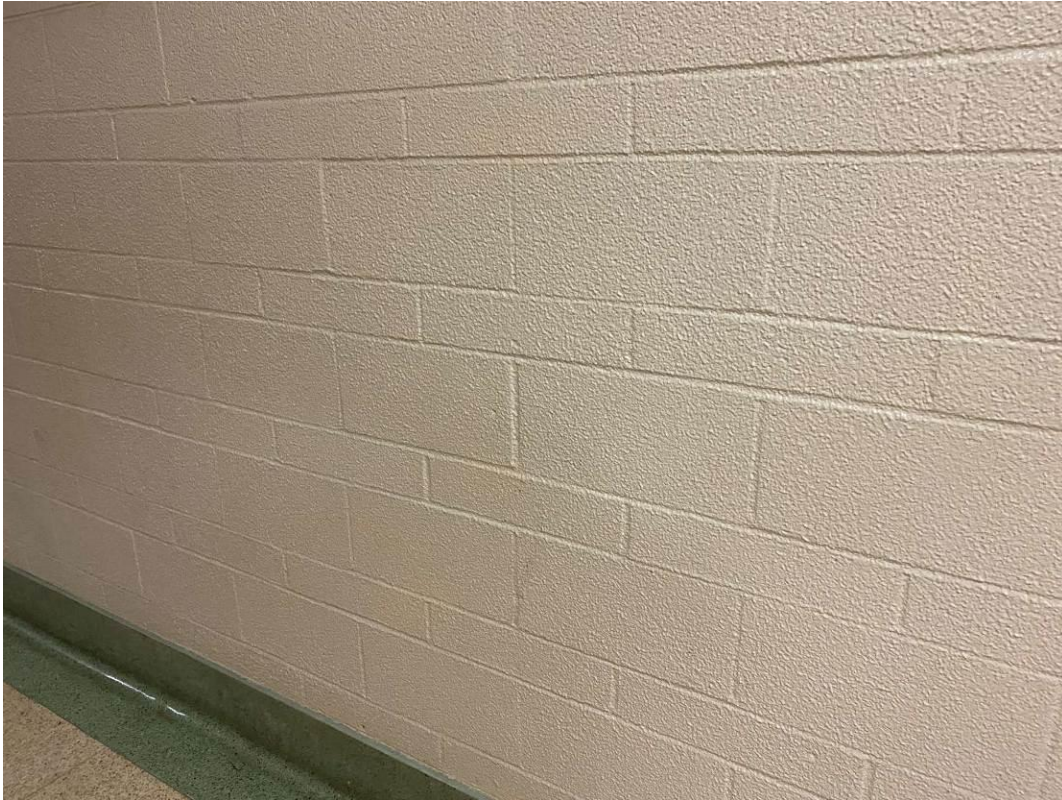
V0025 (None), Textured, Wall, Paint, Stairwell (Location #: 2990)

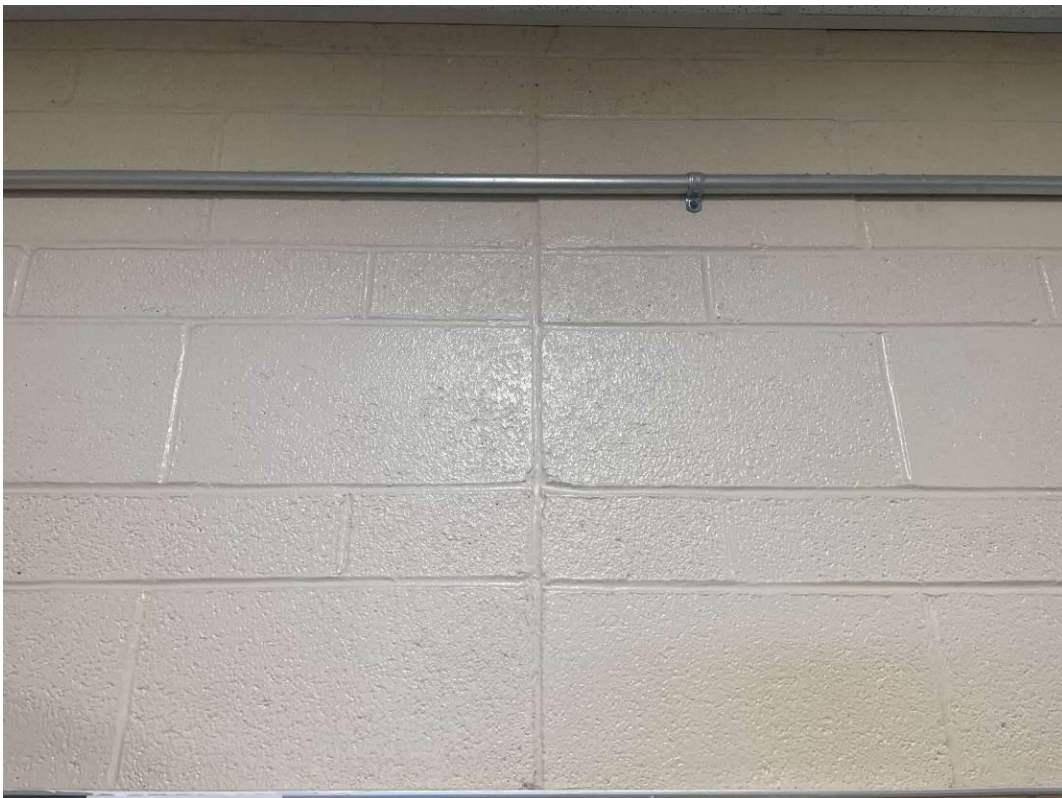
S0026A (Confirmed Asbestos), Other, Expansion Joint, Caulking, Corridor 2 (Location #: 3003)

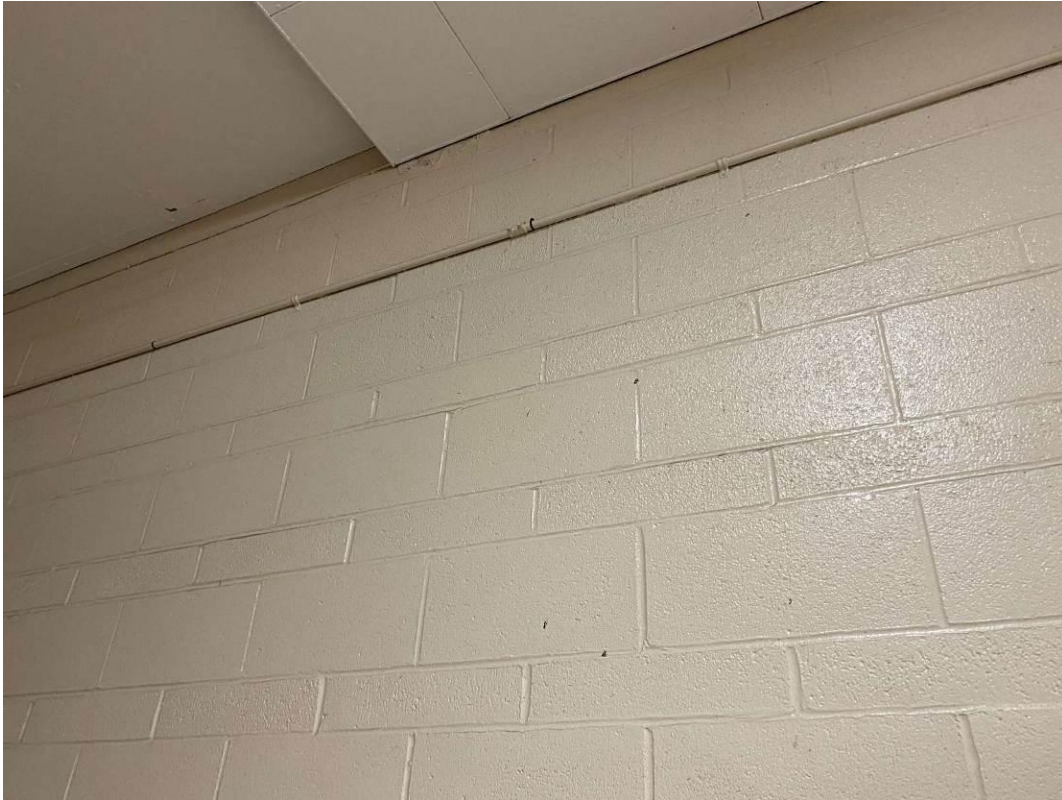
V0028 (None), Smooth, Wall, Paint, Stairwell (Location #: 2990)

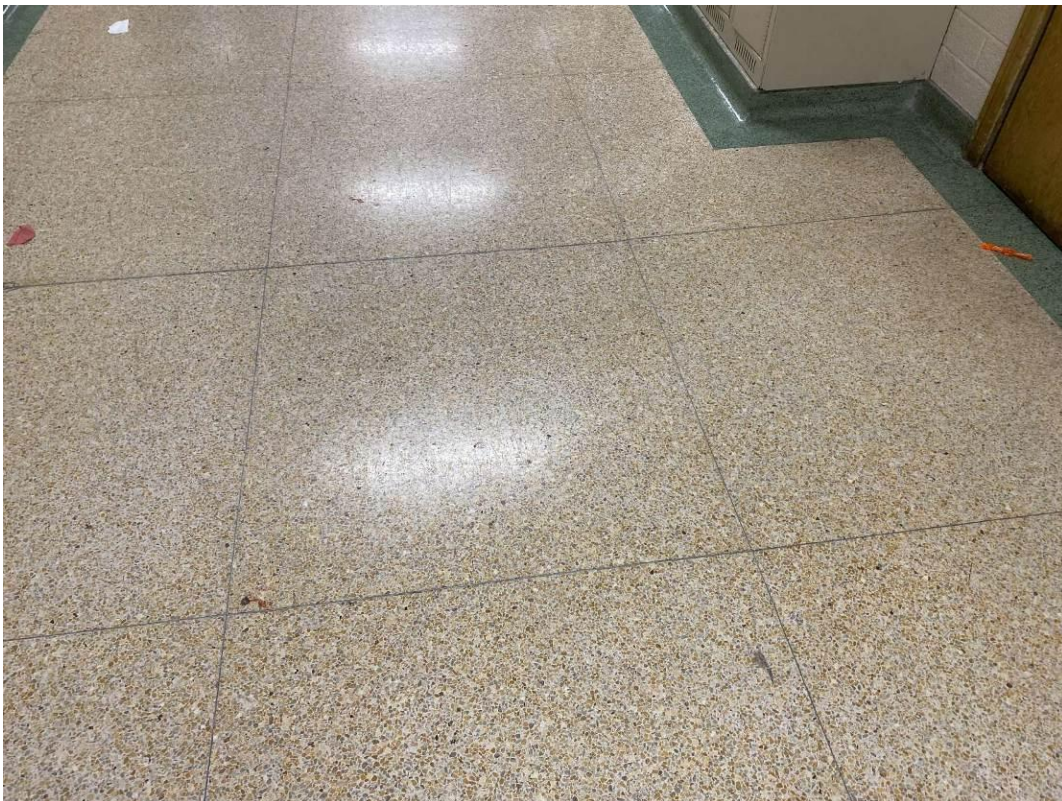
V0029 (None), Floor, Terrazzo, Corridor (Location #: 2984)

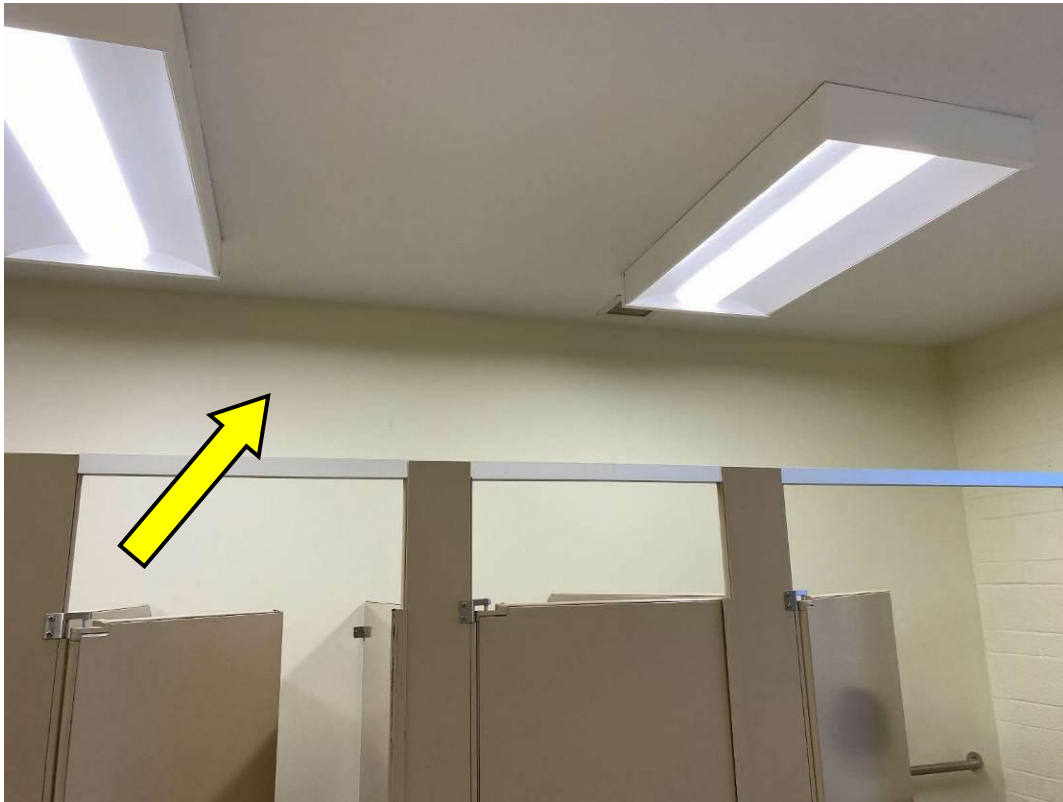
V0030 (None), Wall, Drywall and joint compound, Girls Washroom 2 (Location #: 2976)

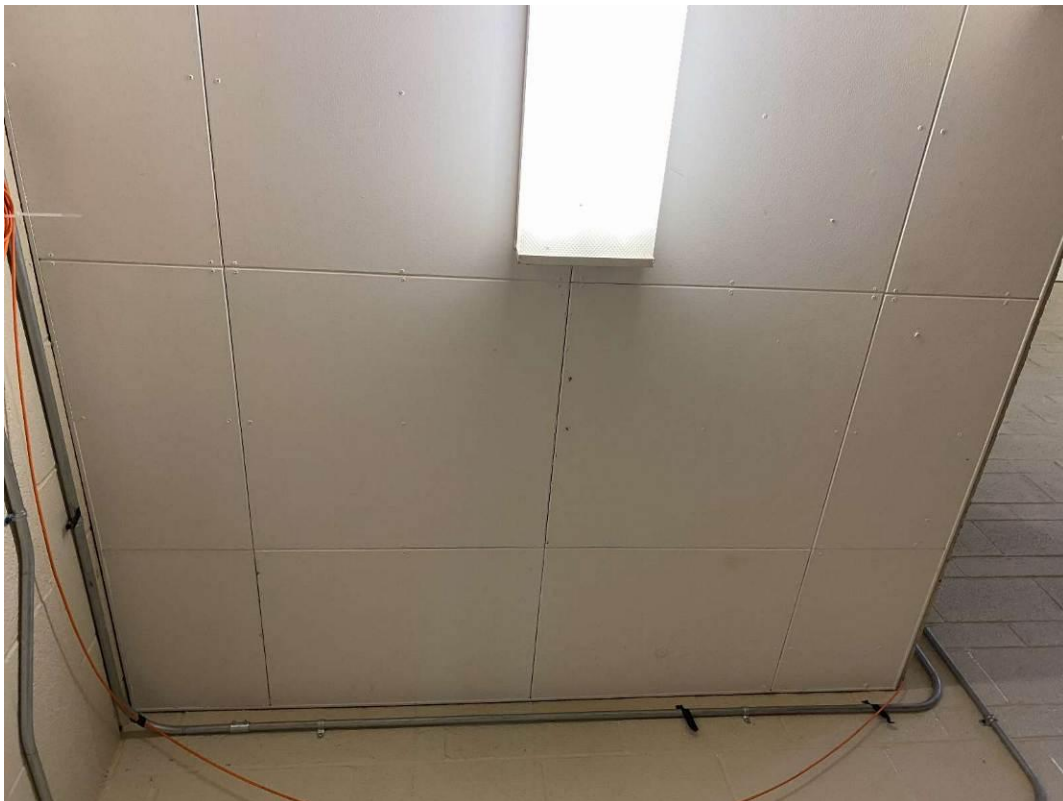
V0036 (Confirmed Asbestos), Ceiling, Cement Product (Transite), Stairwell (Location #: 2990)

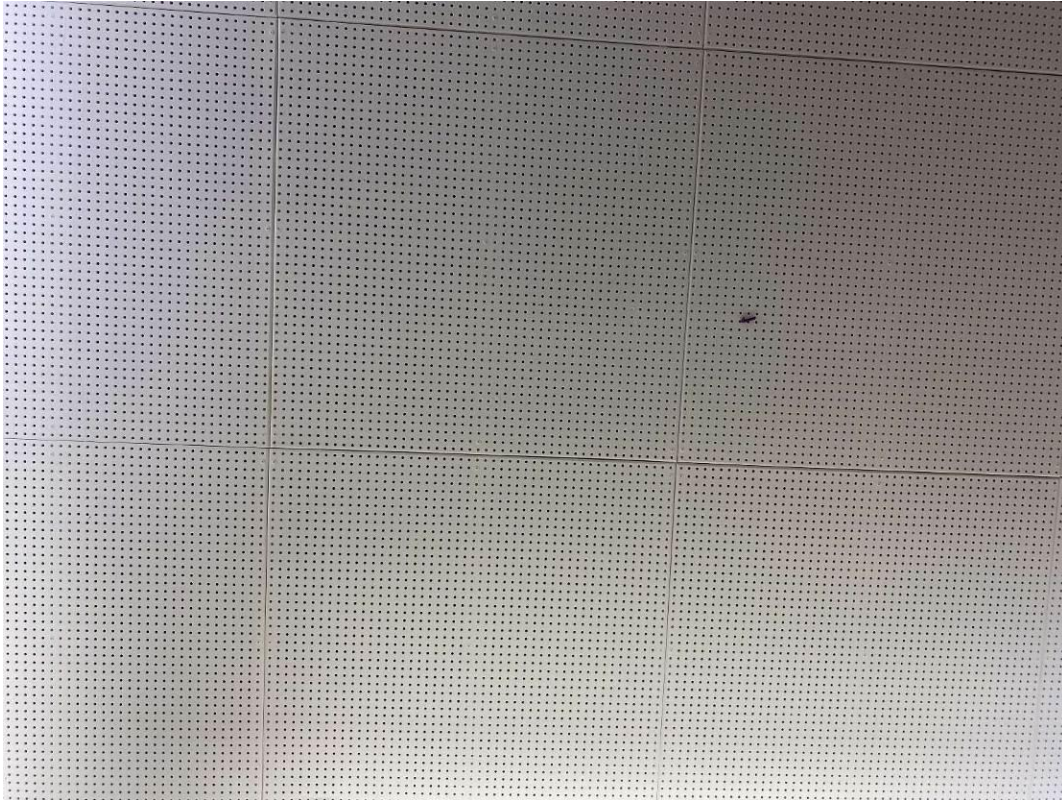
V0036 (Confirmed Asbestos), Ceiling, All, Cement Product (Transite), Classroom (Location #: 2991)

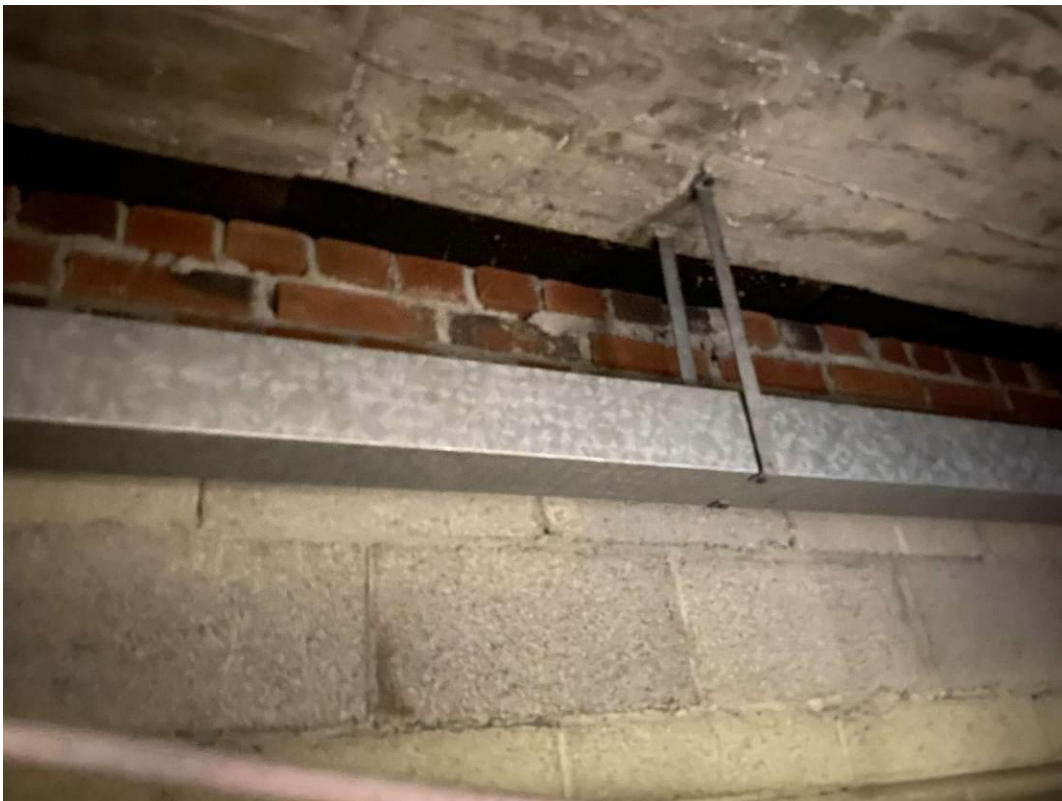
S0037B (None), Black felt, Structure, Deck, Paper, Corridor (Location #: 2984)

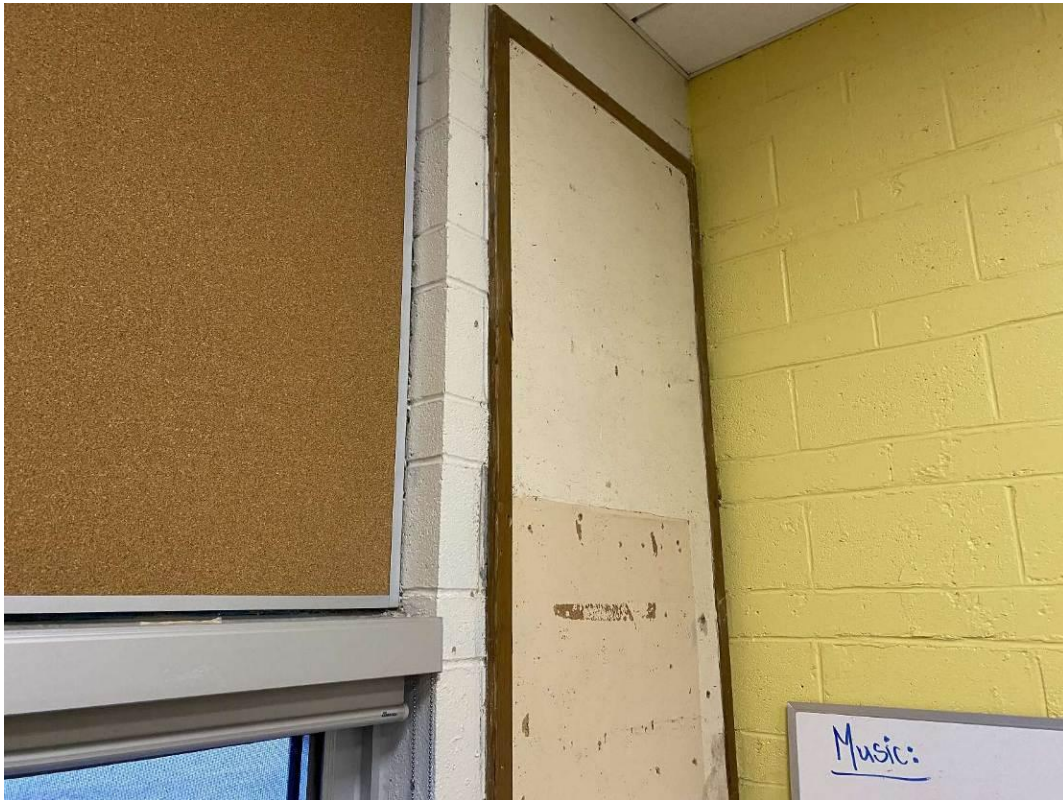
S0040A (None), Tackboard mastic, Other, Mastic, Classroom (Location #: 2991)  
Behind tackboard

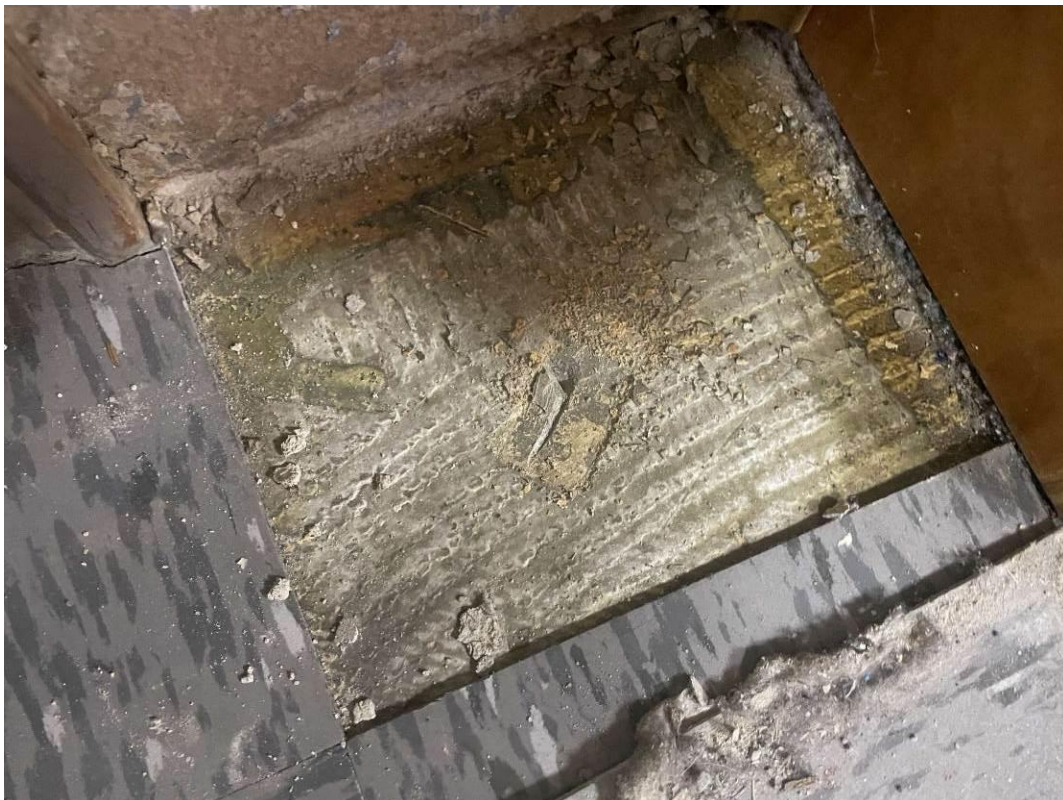
S0041A (None), Under Vinyl floor tiles, Floor, Floor Levelling Compound, Learning Commons (Location #: 2972)

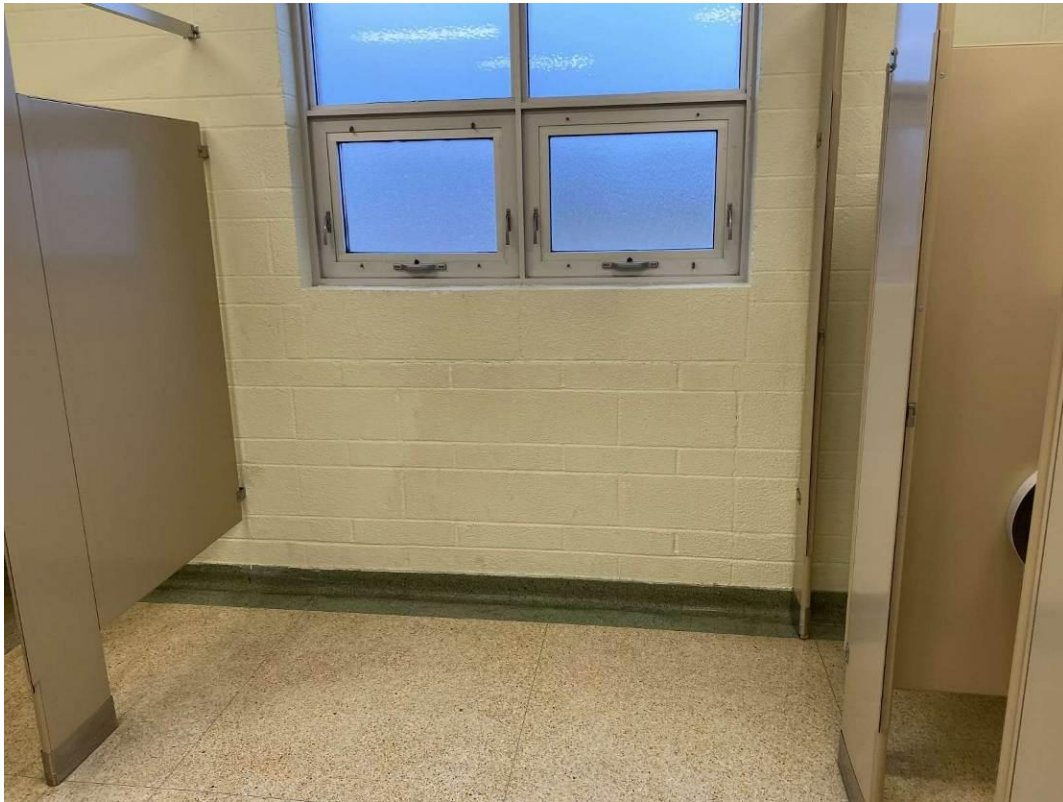
V0001(Lead, Low), Off white paint on masonry wall, Wall, Girls Washroom 2 (Location #: 2976)

For paints identified as having low levels of lead (i.e., equal to or above 0.009% (90 mg/kg) but less than or equal to the EACC guideline of 0.1% (1,000 mg/kg) for lead-containing paints) special precautions are not recommended unless aggressive disturbance (grinding, blasting, torching) is planned.

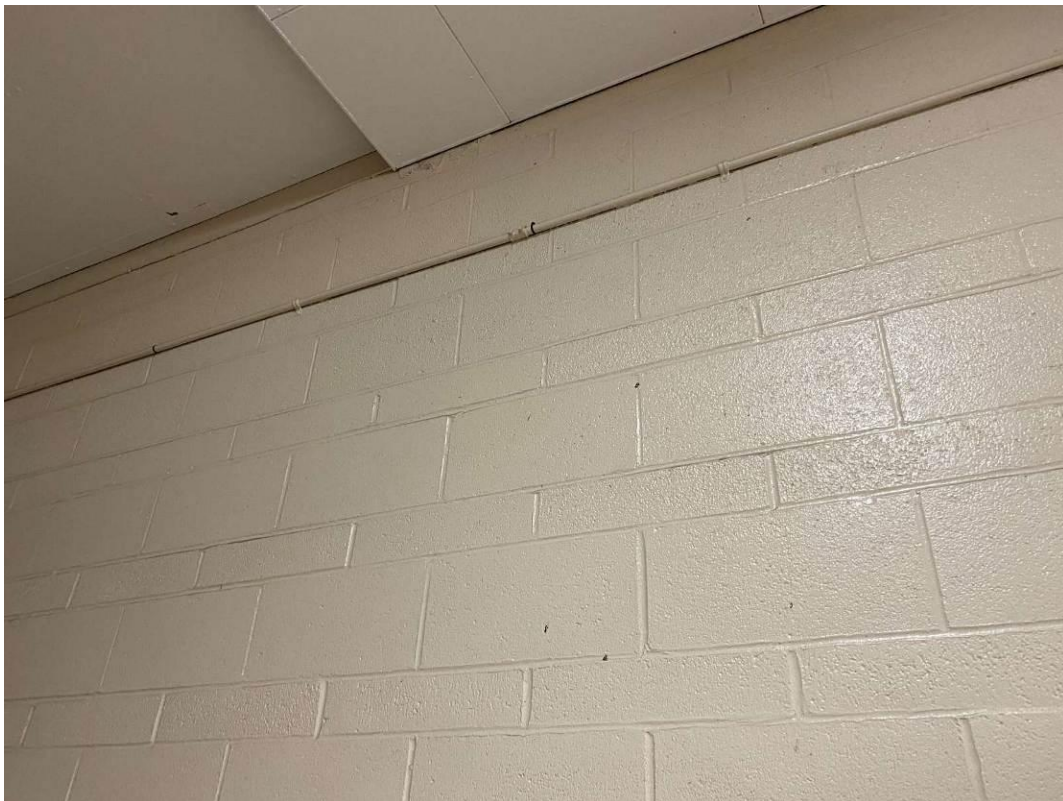
V0001(Lead, Low), Off white paint on masonry wall, Wall, Stairwell (Location #: 2990)

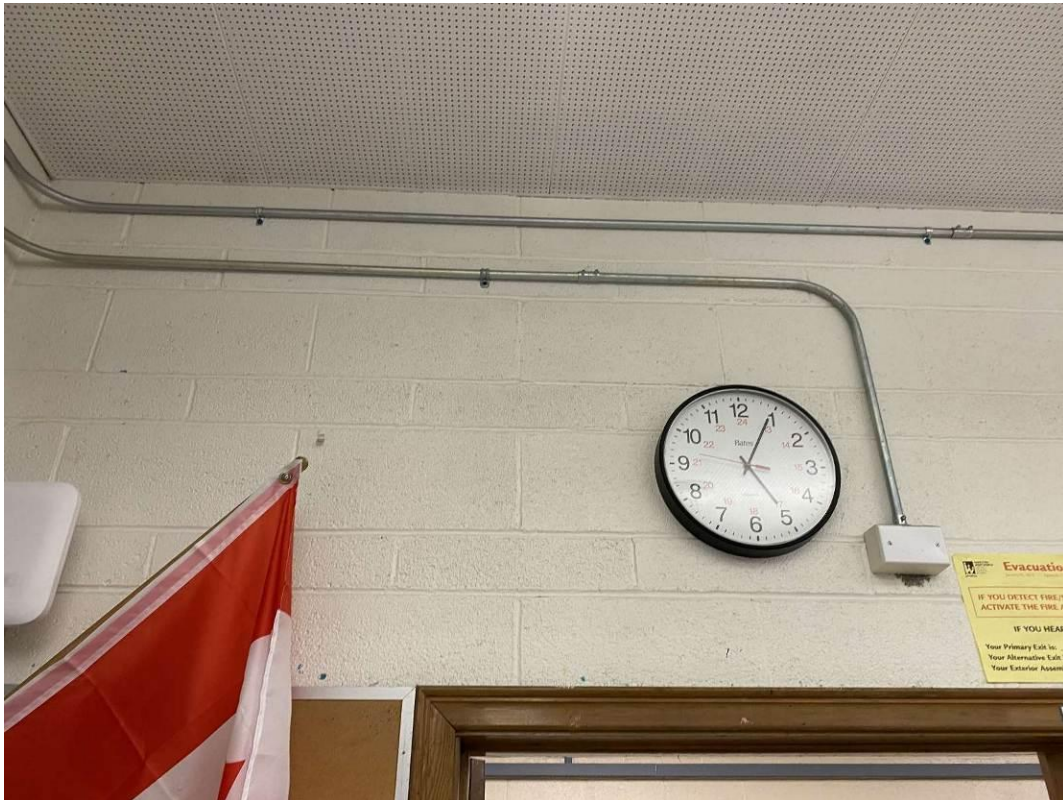
V0003(Lead, Low), Beige paint on masonry wall, Wall, Classroom (Location #: 2991)

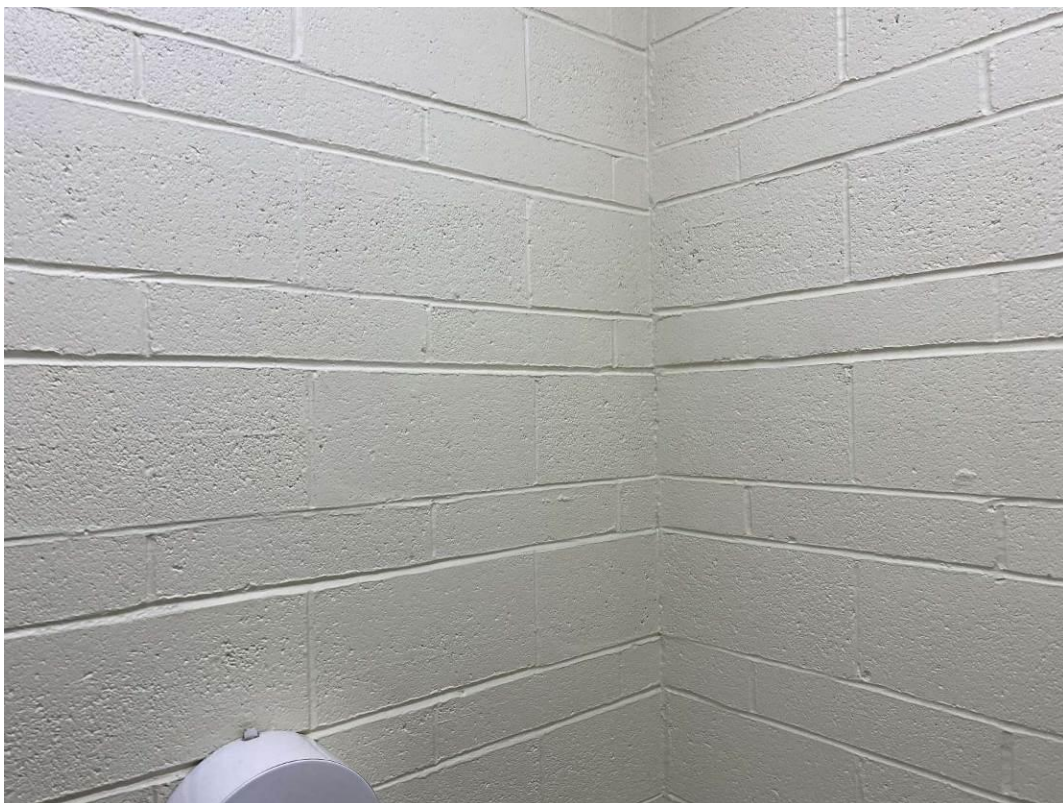
V0005(Lead, None), Cream, Wall, Staff Washroom (Location #: 2999)

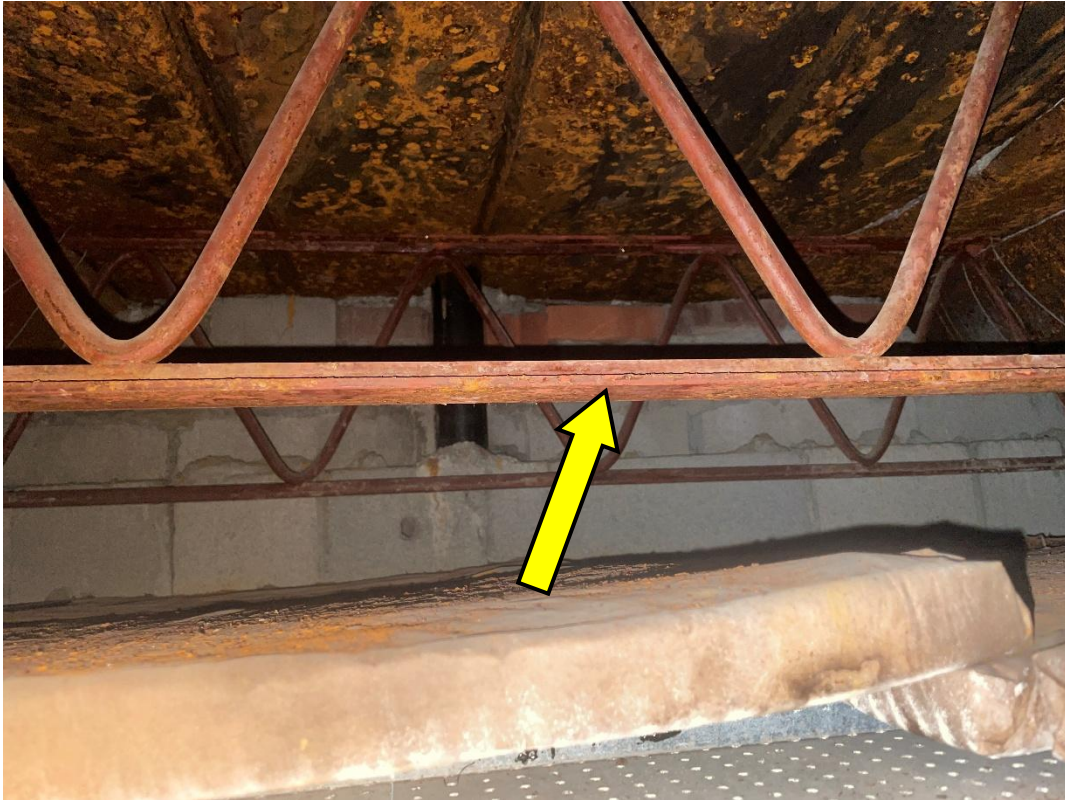
S0011(Lead, High), Red Primer, Structure, Corridor 2 (Location #: 3003)

Items painted with paints containing elevated levels of lead may be a hazardous waste. Test lead-painted materials for leachable lead and other metals prior to disposal. Metallic components coated with lead paint do not require leachate testing and can be disposed of as non-hazardous construction and demolition (C&D) waste.

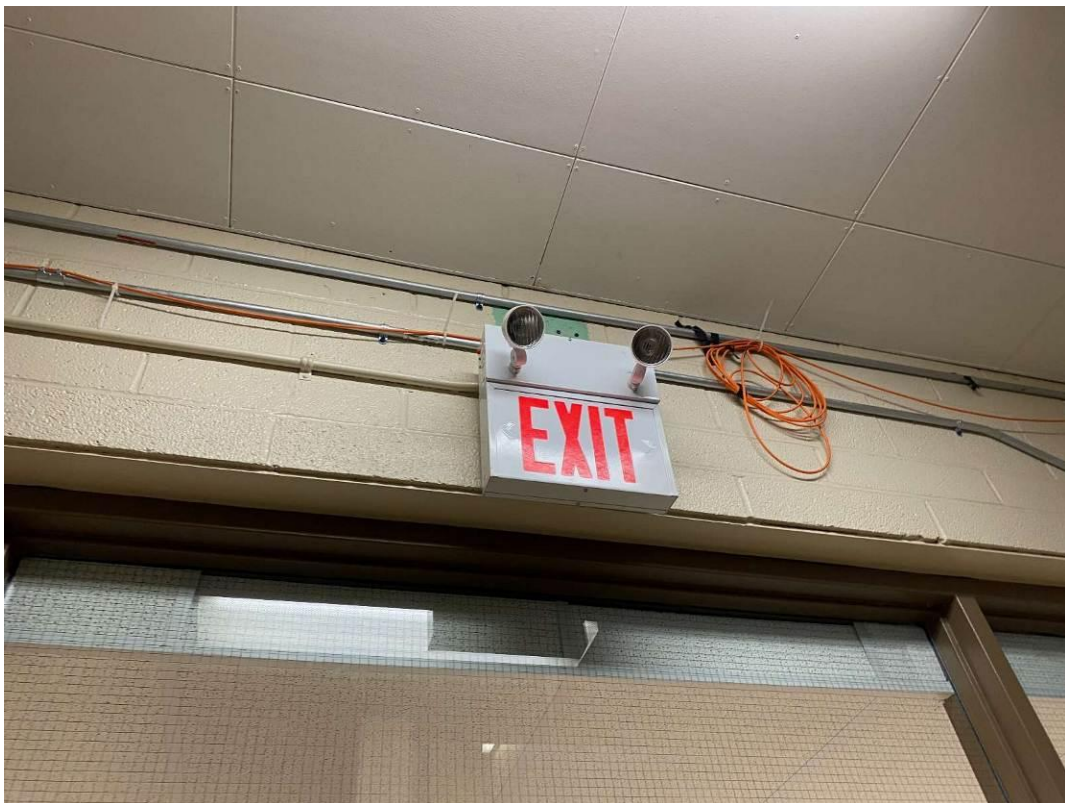
Pb Products, V9000(Yes), Batteries in Emergency lights, Stairwell (Location #: 2990)
