**Re:**               **Hazardous Building Materials Assessment (Preconstruction)**  
Accessibility Upgrades Project  
Norwood Park Elementary School, 165 Terrace Drive, Hamilton, ON  
Pinchin File: 352293.011

Hamilton-Wentworth District School Board (Client) retained Pinchin Ltd. (Pinchin) to conduct a hazardous building materials assessment of Norwood Park Elementary School located at 165 Terrace Drive, Hamilton, ON.

The objective of the assessment was to identify specified hazardous building materials in preparation for building renovation activities. The proposed work as identified by the Client includes renovations to repurpose rooms for the construction of an elevator shaft.

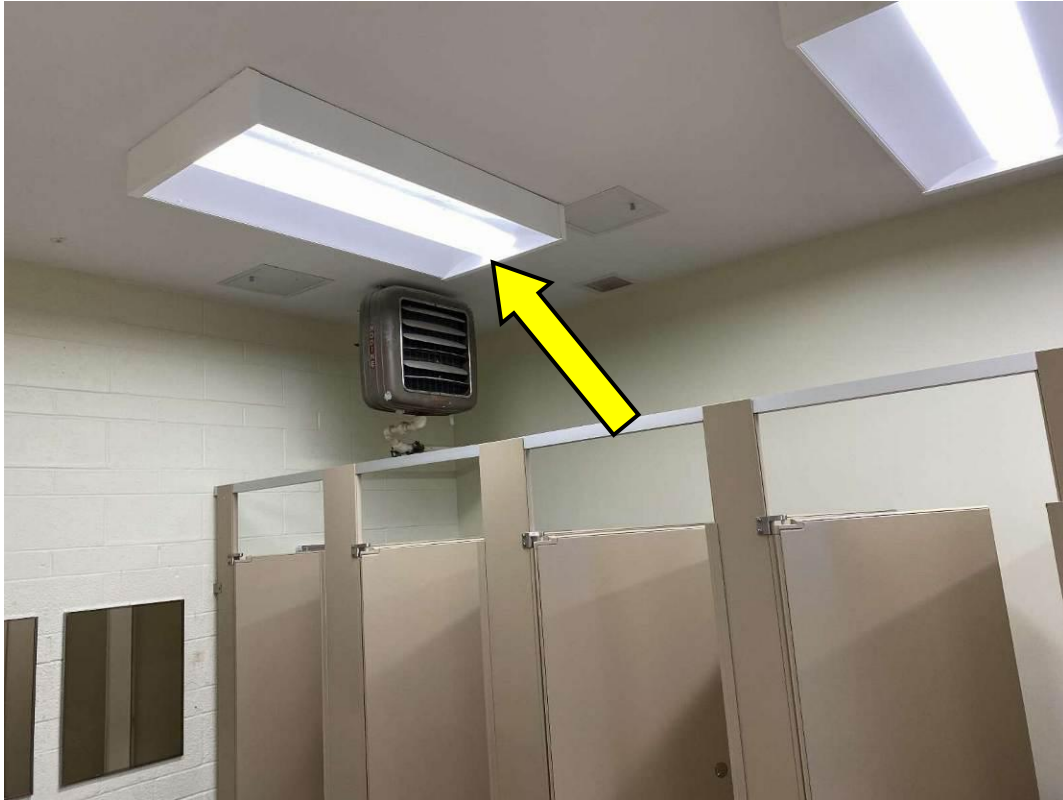
Mercury, V9500(Presumed), LIGHT FIXTURE, Girls Washroom 2 (Location #: 2976)

Do not break lamps. Recycle and reclaim mercury from fluorescent lamps when taken out of service. Mercury is classified as a hazardous waste and must be disposed of in accordance with applicable regulations.
