Designated Substance Survey Report

41 Jackson St., W.

Hamilton, Ontario

Project: C6084

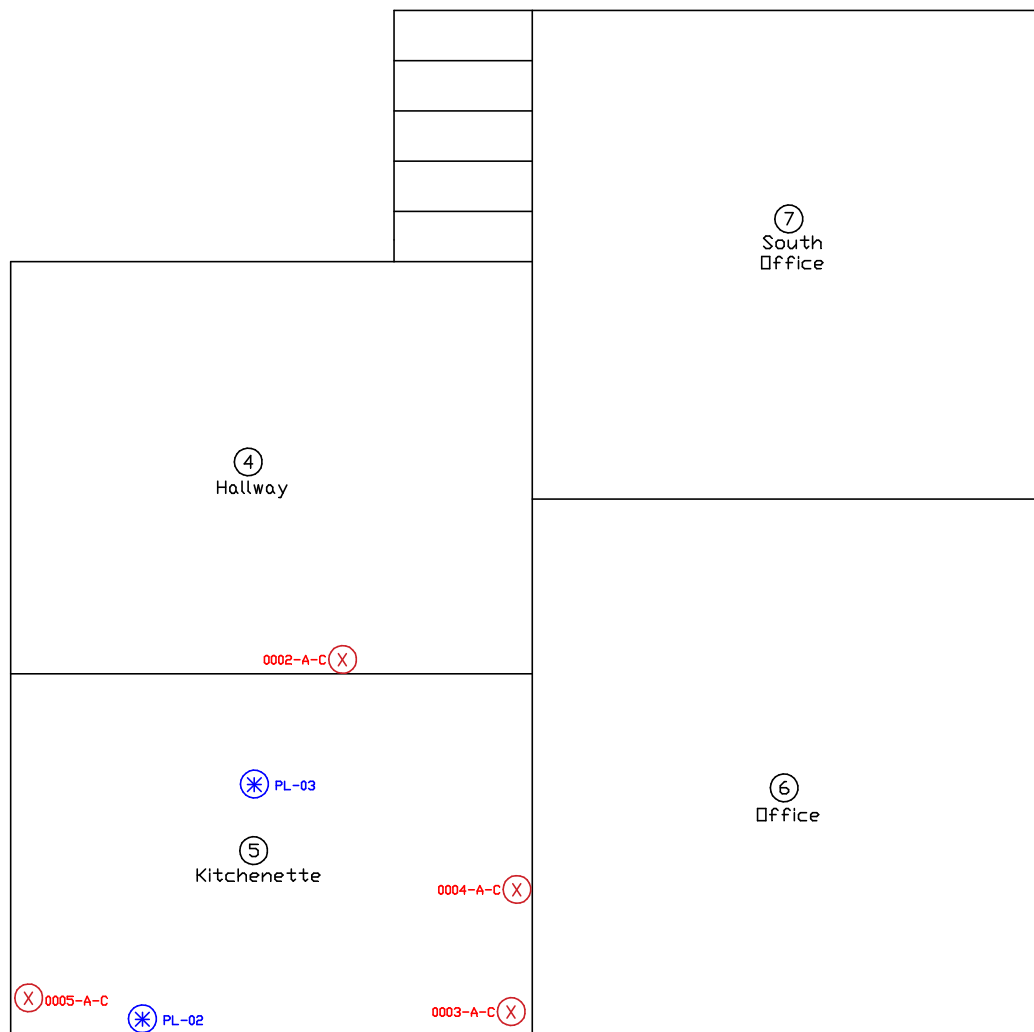
Three (3) samples of parging cement insulation present on pipe fittings throughout the Basement Level of the building were collected and analyzed for asbestos content (samples 0004 A-C). The parging cement insulation has been analytically determined to contain **chrysotile asbestos**. Parging cement insulation is a friable material. The chart below details locations, conditions and approximate quantities:

Three (3) samples of aircell insulation present on pipe straights throughout the Basement Level of the building were collected and analyzed for asbestos content (samples 0005 A-C). The aircell insulation has been analytically determined to contain **chrysotile asbestos**. Aircell insulation is a friable material. The chart below details locations, conditions and approximate quantities:
